**MULTI-CONTOUR SEAT - ADJUSTMENT OR MASSAGE FEATURE
INOPERATIVE - SCMG AND/OR SCMH AIR PUMP CONTINUALLY RUNS -
BUILT ON OR BEFORE 4/21/2015**

TSB 15-0093

2015 F-150

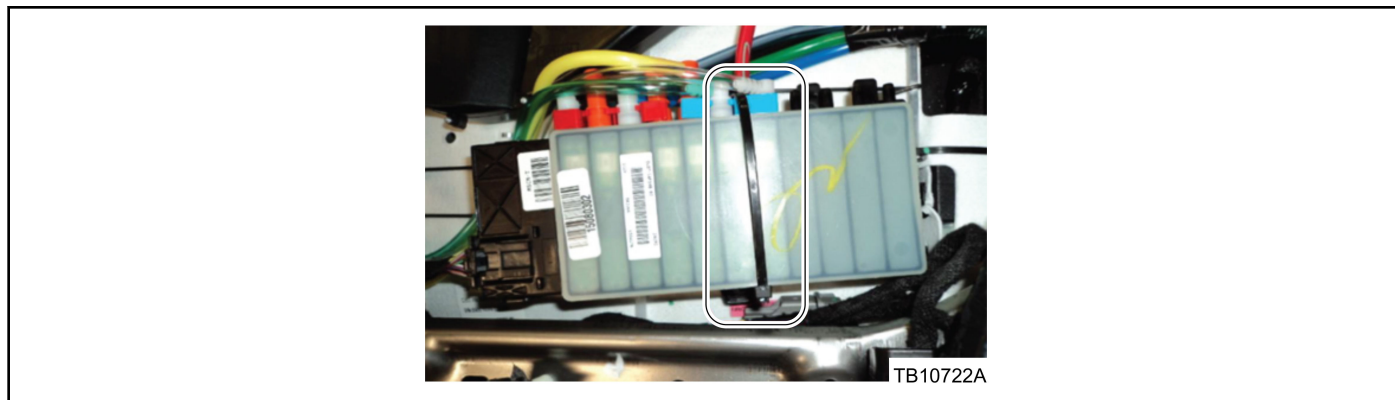
Figure 1 - Article 15-0093

Some 2015 F-150 vehicles equipped with the multi-contour seat option and built on or before 4/21/2015 may exhibit an inoperative seat adjustment, massage feature and/or a driver multi-contour seat module (SCMG) or passenger multi-contour seat module (SCMH) air pump continually running.

1. Does the vehicle exhibit one or more front seats with an inoperative seat adjustment, massage feature and/or an SCMG or SCMH air pump continually running?
 - a. Yes - proceed to Step 2.
 - b. No - this article does not apply.
2. Access both the SCMG and the SCMH. Refer to the Workshop Manual (WSM), Section 501-10.
 - a. Removal of the modules is not necessary.
3. Use a nylon cable tie at least 254 mm (10 in.) long and wrap one around each the SCMG and the SCMH and each blue connector to secure the connection. (Figure 1)
