FORD:

2016 F-150

Some 2016 F-150 vehicles built on or before 10/28/2015 may exhibit a tailgate ajar light and/or warning message displayed in the instrument panel cluster (IPC) with the tailgate fully closed.

TSB 16-0030 (Continued)

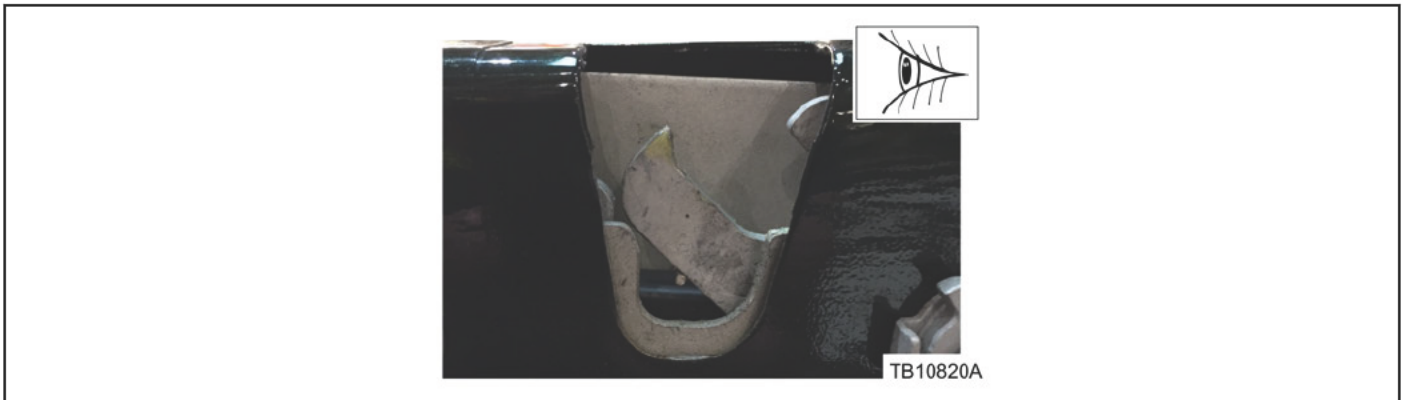
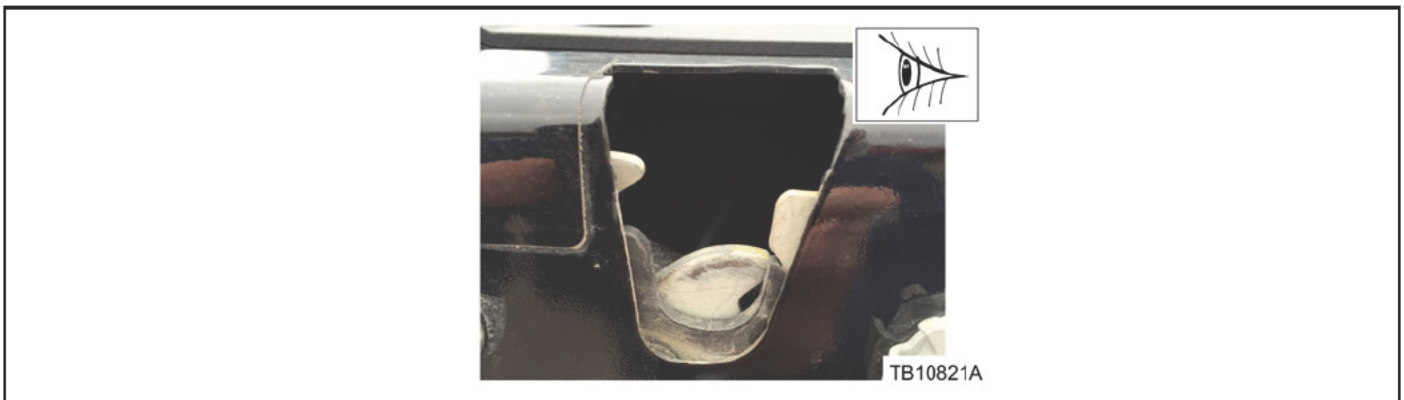
Figure 1 - Article 16-0030

1. Inspect the left and right side tailgate latch assemblies. Is there a metal back on the inside of the latch? (Figures 1- 2)

- a. Yes - proceed to Step 6.
 - b. No - proceed to Step 2.
2. Replace the left and right tailgate latches and latch actuating rods. Refer to the Workshop Manual (WSM), Section 501-14.

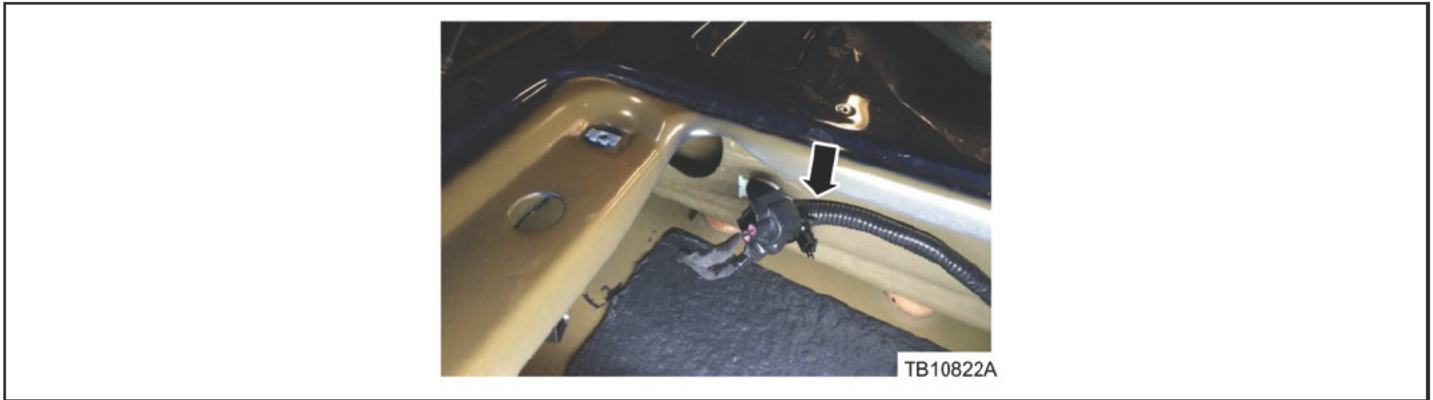
Figure 3 - Article 16-0030

- a. Make sure the left and right side actuating rods are positioned in the clips they release the latches at the same time.
 - b. Do not reinstall the tailgate access panel until Step 10 is complete.
3. Is the tailgate ajar switch wiring harness connector unplugged and secured? (Figure 3)

- a. Yes - proceed to Step 6.
 - b. No - proceed to Step 4.
4. Install the delete cap onto the tailgate ajar switch wiring harness connector. (Figure 4)
