General Service Bulletin (GSB):	Environmental Fallout Paint Damage
GSB Overview:	Use this GSB to help determine warrantable/non-warrantable conditions on paint from environmental fallout.
NOTE: This information is not intended to replace or supersede any warranty, parts and service policy, Work Shop Manual (WSM) procedures or technical training or wiring diagram information.

Environmental Fallout Paint Damage

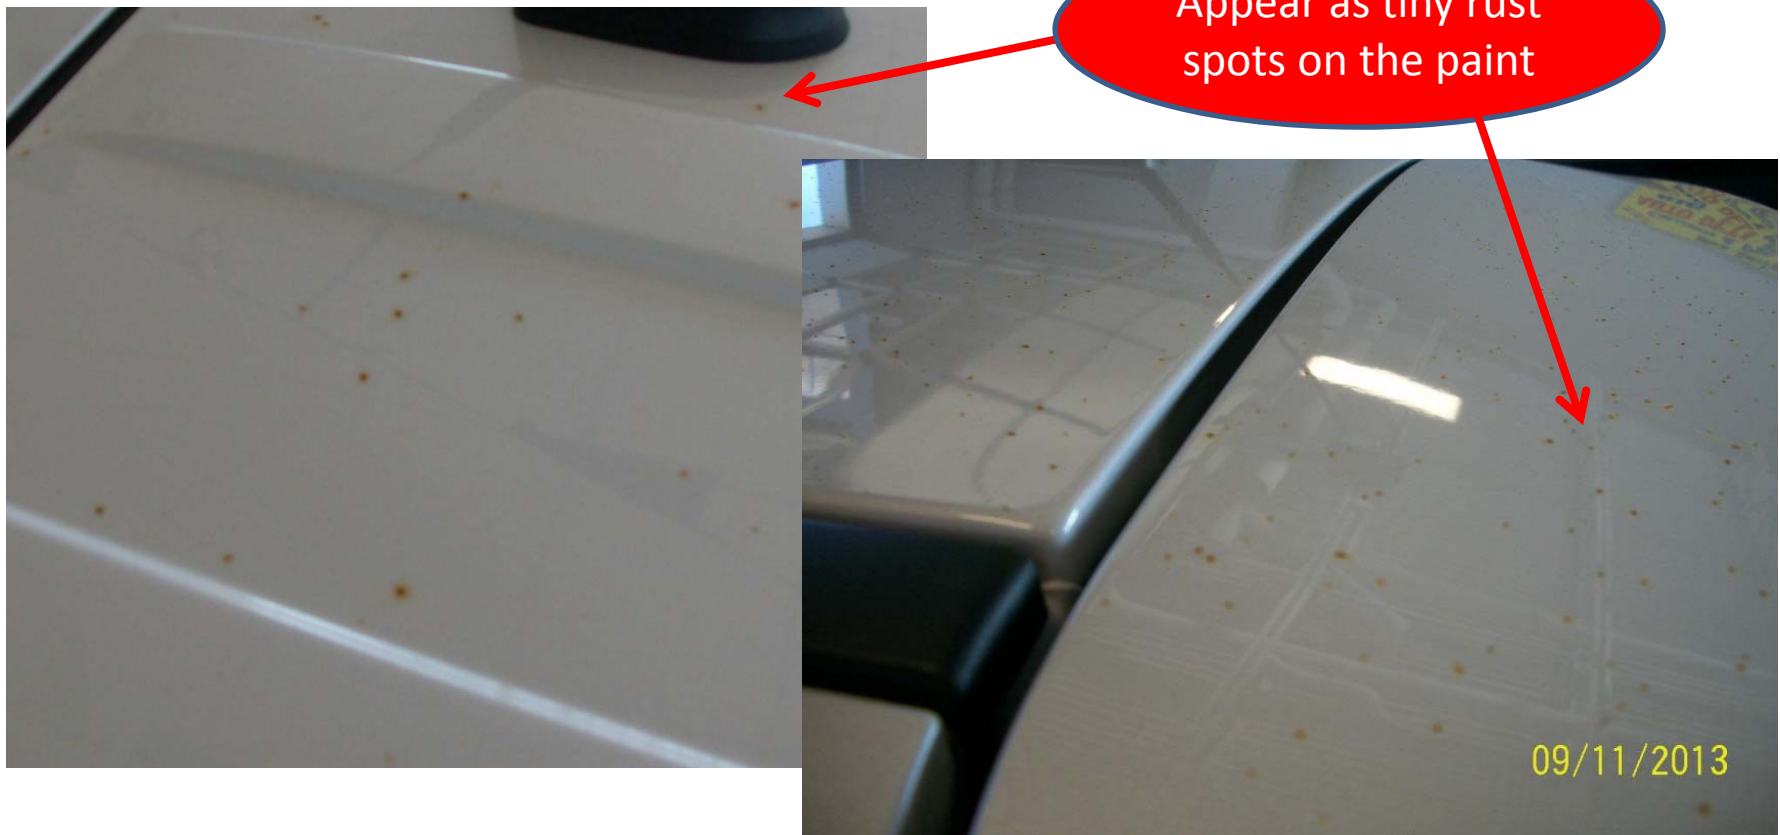
Eligible for Coverage – Iron Oxide (Rail Dust)

- Rust spots may appear to be white on black or dark-colored vehicles.
- Refer to WSM, Section 501-35, to decontaminate and repair the surface finish.

For decontamination and repair of Iron Oxide (Rail Dust) or Acid Rain damage, refer to Workshop Manual (WSM), Section 501-35.

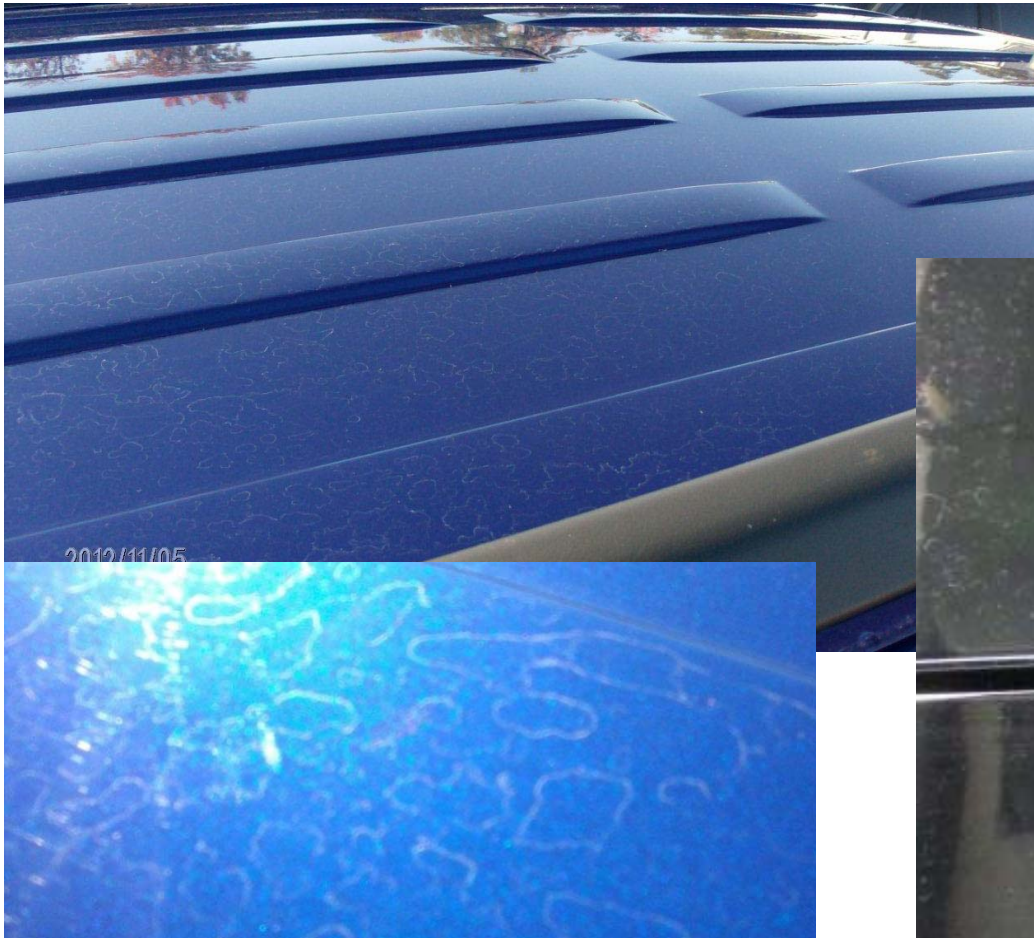
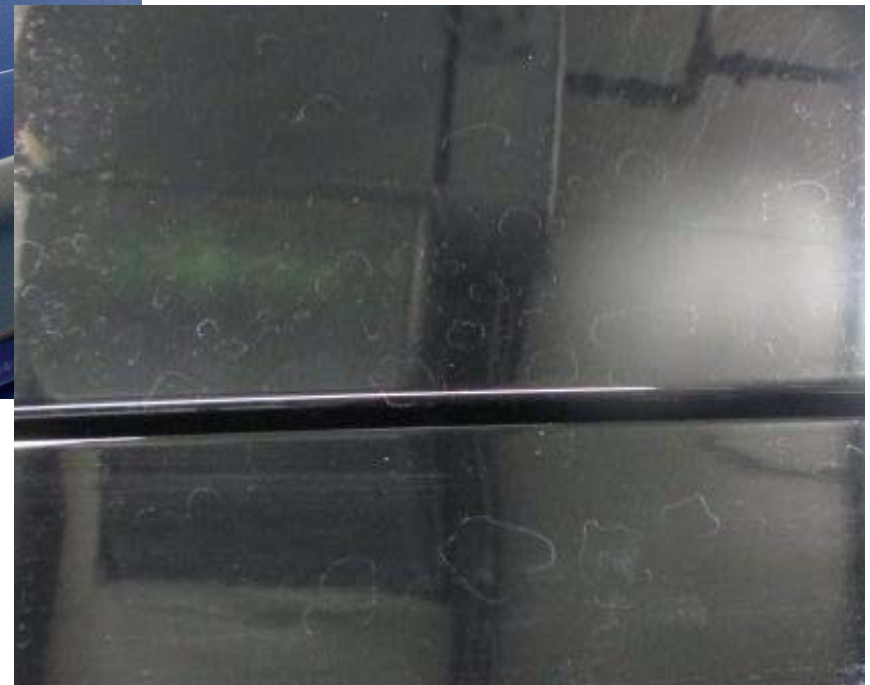
Eligible for Coverage – Acid Rain

Fallout will typically not be limited to one spot on one panel. Since the entire vehicle will be subject to the same conditions, multiple panels are usually affected.

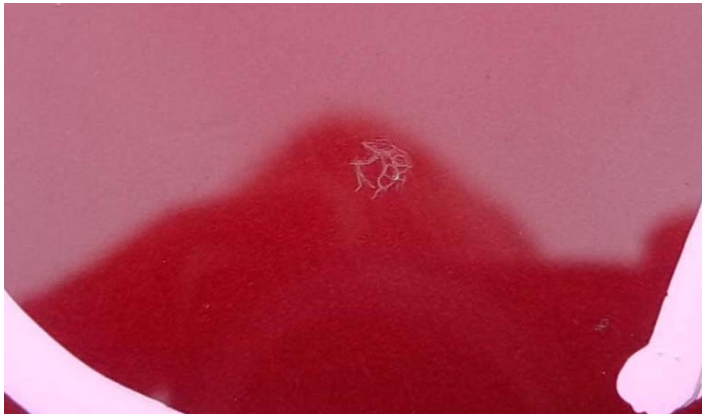
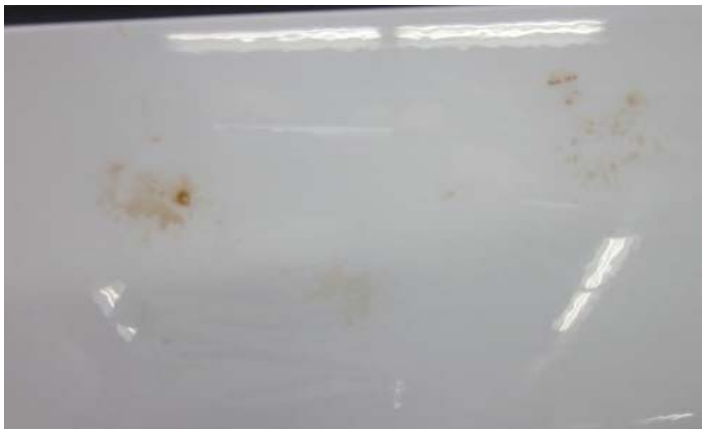
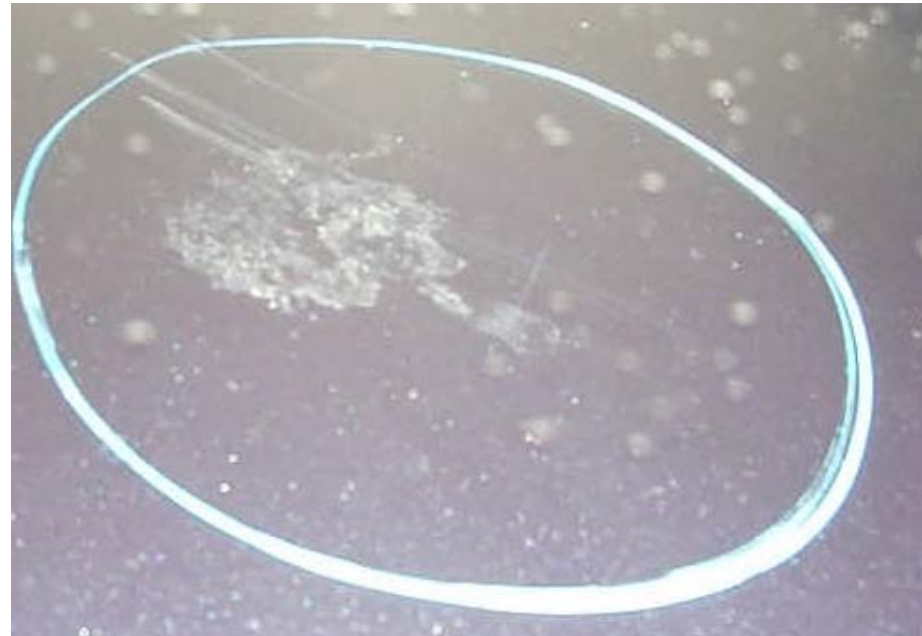
Not Eligible for Coverage

- Environmental paint damage caused by an outside source.
 - Environmental damage is typically limited to one or two spots on the paint. The paint will be etched from the top down and may exhibit a “cracking” appearance.
- Bird droppings
 - Tree sap
 - Stone chips/scratches
 - Hail damage
 - Damage from lightning
 - Damage resulting from flood

Finish damage of this type can be prevented with regular cleaning of the vehicle.
