TECHNICAL SERVICE BULLETIN XL/XLT - Instrument Panel Warped/Separated At Defrost Vents

19-2041
15 February 2019

Ford 2015-2019 F-150

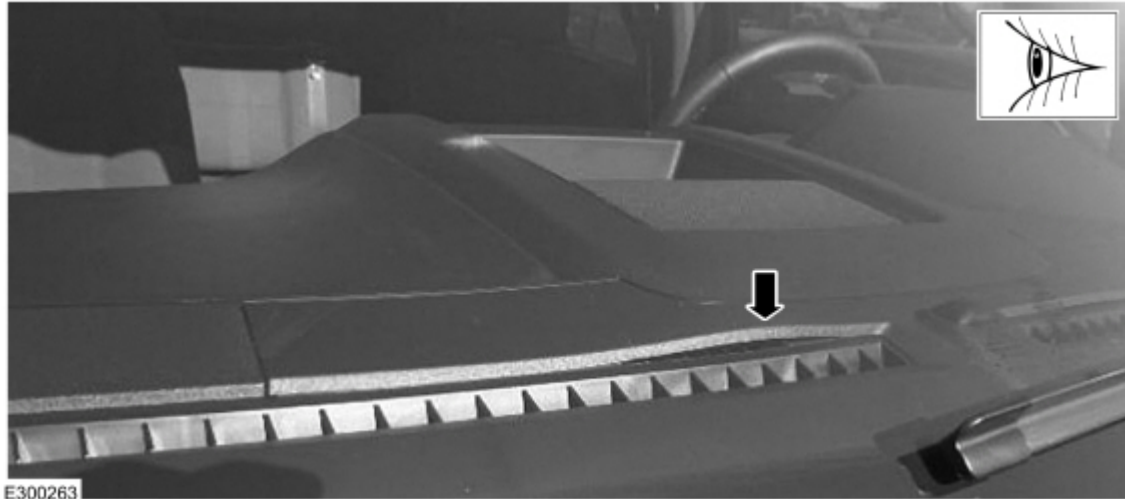
Figure 1

1. Inspect the instrument panel. Does the instrument panel exhibit a warp/separation at the defrost vent as shown in Figures 1 and 2?

2. Replace the instrument panel upper section. Refer to WSM, Section 501-12.
