TECHNICAL SERVICE BULLETIN

4WD - Grinding/Clicking/Ratcheting Noise From Front Wheel Area

22-2219

20 June 2022

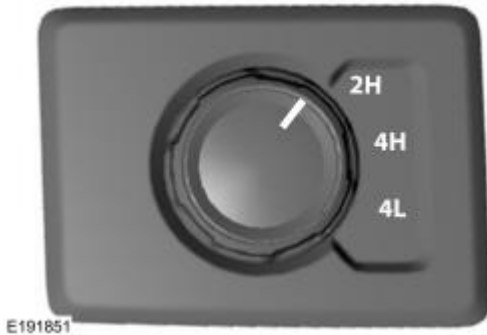
Figure 1 - Example of MSS without 4A selection

1. Does the vehicle have a MSS that only includes 2H, 4H and 4L positions (does not include 4A)? (Figure 1)

- (1). Yes - proceed to Step 2.
 - (2). No - proceed to Step 4.
2. Is the vehicle a 2017-2018 F-150?

(1). Yes - reprogram the TCCM using the latest version of the appropriate Ford scan tool.

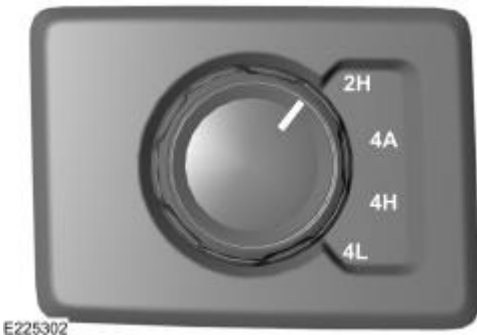
Figure 2 - Example of MSS with 4A selection

4. Does the vehicle have a MSS that includes a 4-wheel auto (4A) option? (Figure 2)

- (1). Yes - proceed to Step 5
 - (2). No - this article does not apply. Refer to the Workshop Manual (WSM) for normal diagnostics.
5. Locate the vacuum supply line between the source vacuum and the IWE check valve. Refer to WSM, Section 308-07A. (Figures 3-4)
