# TECHNICAL SERVICE BULLETIN

## Intermittent Grinding Noise From Integrated Wheel Ends (IWEs) While Driving In Two Wheel Drive (2WD)

**18-2273**

<b>Ford</b> 2013-2018 Expedition
2013-2018 F-150
<b>Lincoln</b> 2013-2018 Navigator

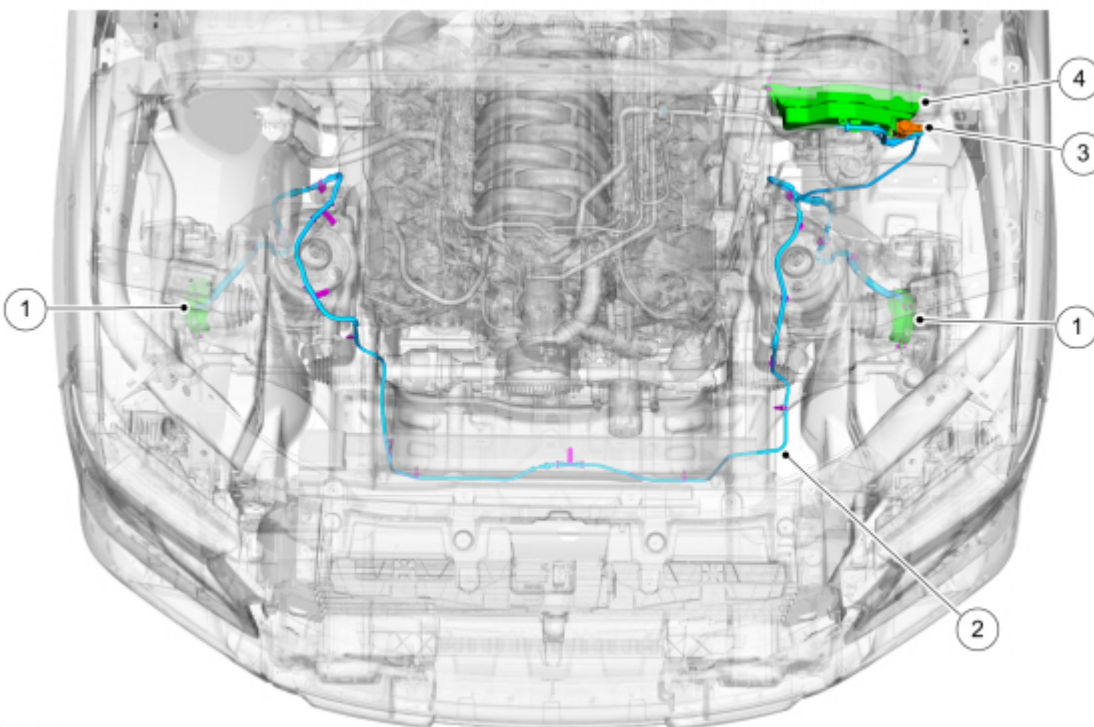
Figure 1

1. Inspect the IWE vacuum hoses. Refer to Workshop Manual (WSM), Section 308-07A. Are there any disconnected or damaged vacuum hoses? (Figure 1)

- (1). Yes - this article does not apply. Refer to WSM, Section 308-07A for normal diagnostics.
- (2). No – proceed to Step 2.
