3.5L GTDI—INTERMITTENT STUMBLE/MISFIRE ON ACCELERATION FROM HIGHWAY CRUISE IN HUMID OR DAMP CONDITIONS WITH POSSIBLE DTC

TSB 12-10-19

2011-2012 F-150

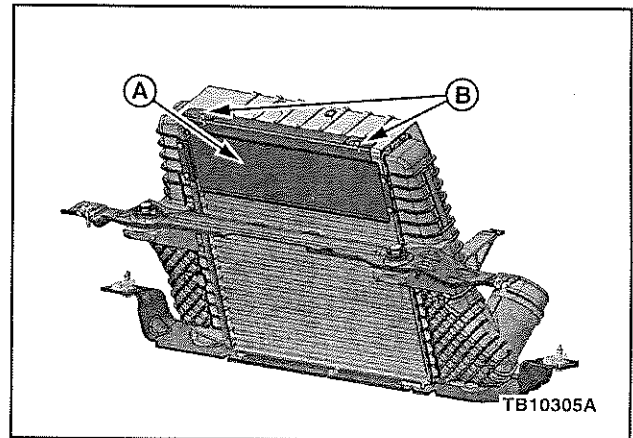
Figure 1 - Article 12-10-19

1. Check for DTC P0430. Is DTC P0430 present?
 - a. Yes - Replace the left bank catalytic converter assembly. Refer to Workshop Manual (WSM), Section 309-00. Proceed to Step 2.
 - b. No - Proceed to Step 3.
2. Is the Charge Air Cooler (CAC) equipped with an air deflector plate? (Figure 1A)

- a. Yes - Proceed to Step 5.
 - b. No - Proceed to Step 3.
3. Install a new CAC, new air deflector plate, and original shield using new retaining pushpins. Refer to WSM, Section 303-12. (Figure 1B) Proceed to Step 4.
 4. Reprogram the PCM to the latest calibration using IDS release 79.02A or higher. This new calibration is not included in the 2012.5 DVD. Calibration files may also be obtained at www.motorcraft.com.
 5. Install a new CAC and the original air deflector plate and shield using new retaining pushpins. Refer WSM, Section 303-12.
