**UN-COMMANDED TCC APPLY ON THE 1-2 SHIFT
CAUSING PERCEPTION OF HESITATION AND/OR
LACK OF POWER DURING SHIFT**

TSB 09-20-14

FORD:

2005-2010 Crown Victoria
2005-2006 Expedition
2005-2010 E-150, E-250, E-350, F-150

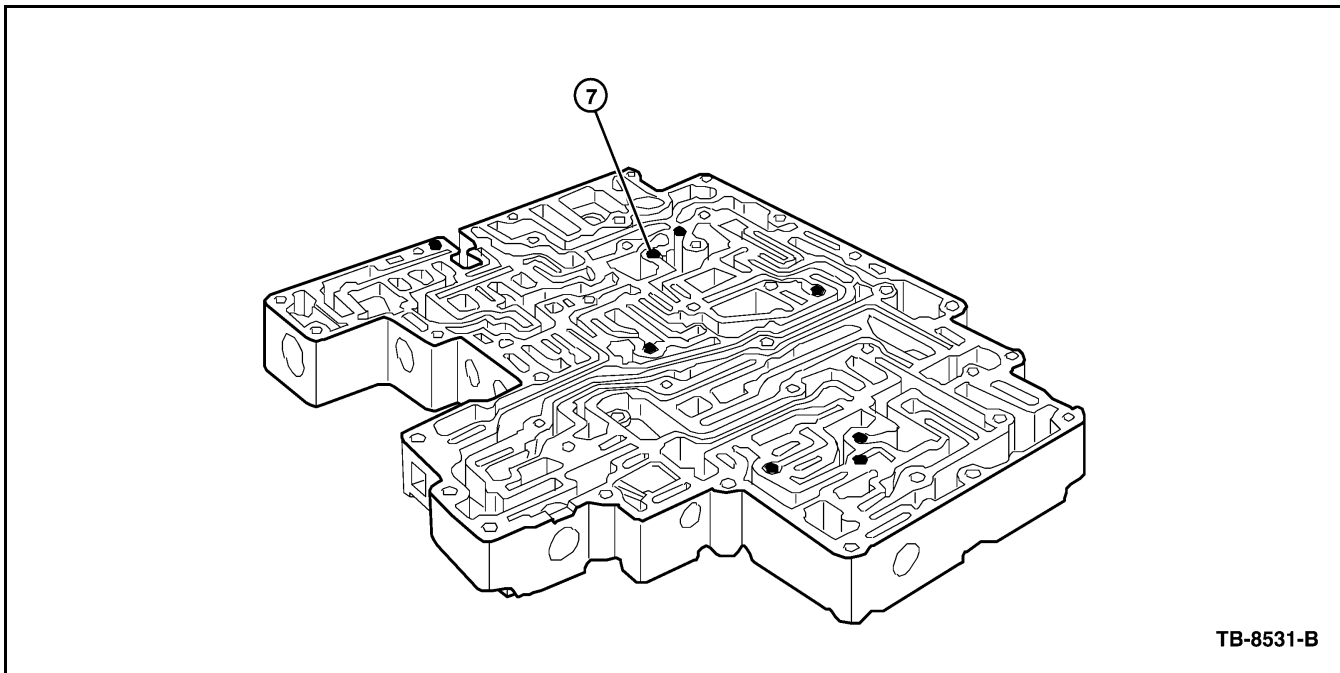
Figure 1 - Article 09-20-14

Some 2005-2010 vehicles equipped with a 4R70/75E-W transmission may experience an un-commanded torque converter clutch (TCC) apply or TCC partial apply immediately after the 1-2 shift. This may result in the perception that the vehicle lacks power or that the transmission is up-shifting too early. Additional symptoms of uncommanded TCC apply when coming to a stop (before the 2-1 downshift is commanded), are engine stalling or lugging when engaging manual 2nd while at a stop and code P1742 may be present in continuous memory. However, the vehicle should operate normally in park, reverse, neutral and manual 1st gear.

1. Monitor (TCC %) solenoid command state - duty cycle and (TC SLIP ACT) torque converter clutch slippage - RPM, while in 2nd, 3rd or 4th gear with a TCC % reading 0.
 - a. If TCC % = 0 and TC SLIP ACT = less than 20 RPM then inspect the number 7 check ball in the main control valve body for damage. Replace as required following the appropriate Workshop Manual (WSM) under Disassembly and Assembly of Subassemblies - Main Control Valve Body. (Figure 1)
