Printable View	
TSB 15-0140	LARIAT/PLATINUM/KING RANCH - CLIMATE CONTROLLED SEATS - FRONT SEAT BACKRESTS NOT COOLING
Publication Date: September 8, 2015

FORD: 2015 F-150

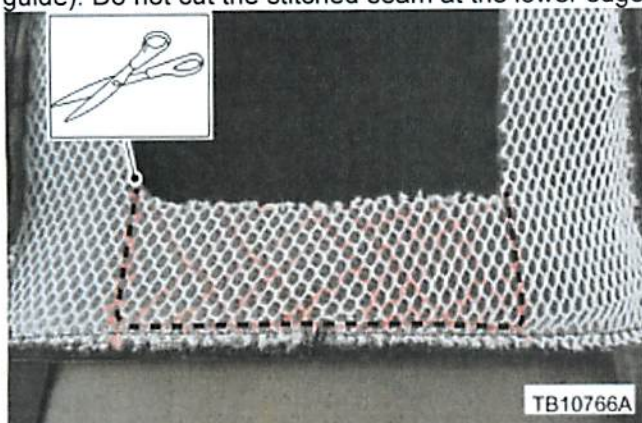
Figure 1 - 15-0140

Some 2015 F-150 Lariat, Platinum and King Ranch vehicles equipped with climate controlled seats may exhibit a lack of cooling in the front seat backrests.

1. Does this vehicle exhibit a lack of cooling in only the front seat backrest when using the climate controlled seats?
 - a. Yes - proceed to Step 2.
 - b. No - this article does not apply. Refer to Workshop Manual (WSM), Section 501-10 for normal diagnostics.
2. Can the backrest blower motor be heard running when using the climate controlled seats?
 - a. Yes - proceed to Step 3.
 - b. No - this article does not apply. Refer to WSM, Section 501-10 for normal diagnostics.
3. Remove the front seat backrest blower motor. Refer to WSM, Section 501-10.
4. With the seat backrest cover positioned upward, use scissors or equivalent cutting device to remove the indicated portion of the seat backrest cover foam spacer pad (using the existing spacer pad opening as a guide). Do not cut the stitched seam at the lower edge of the seat backrest cover. (Figure 1)
