FORD:

2015 F-150

ISSUE

Some 2015 F-150 Lariat, Platinum and King Ranch vehicles equipped with climate controlled seats may exhibit a lack of cooling performance in the front seat backrests.

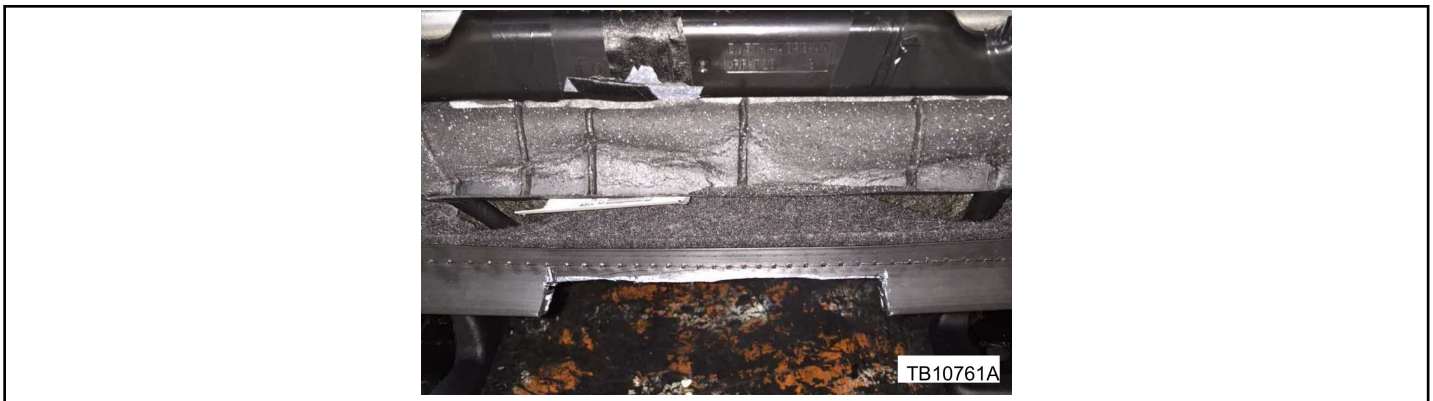
Figure 3 - Article 15-0154

- 6. Use diagonal cutting pliers or equivalent to remove the plastic J-clip section between these two new marks on both J-clips. (Figure 3)
