FORD:

2015-2016 F-150

Some 2015-2016 F-150 vehicles may exhibit a rattle and/or squeak noise from the vista roof opening panel while the panel is closed and the vehicle is being driven.

TSB 16-0020 (Continued)

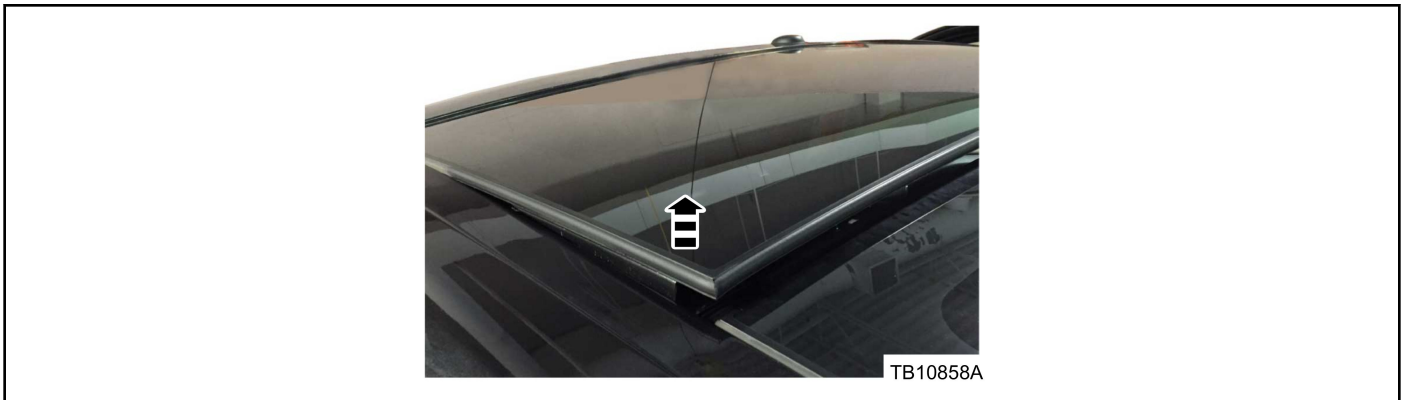
Figure 1 - Article 16-0020

1. Position the glass panel to the vent position. (Figure 1)

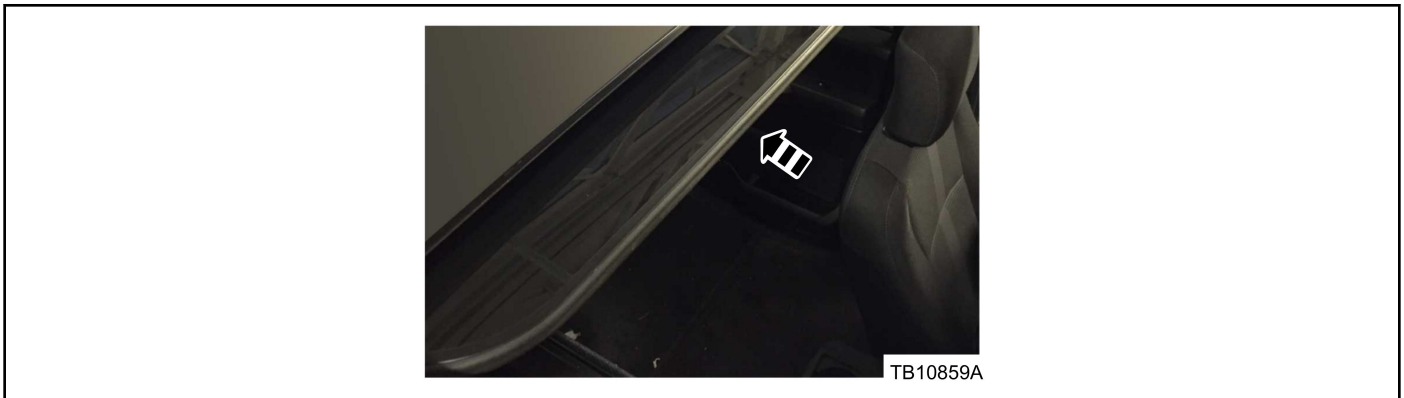
Figure 2 - Article 16-0020

2. Clean the rear and side rubber seals of the movable glass panel with isopropyl alcohol.
3. Clean the exposed sheet metal of the roof opening with isopropyl alcohol.
4. Position the glass panel to the fully open position. (Figure 2)

5. Clean the remaining front rubber seal area of the movable glass panel with isopropyl alcohol.
6. Clean the remaining exposed sheet metal of the roof opening with isopropyl alcohol.

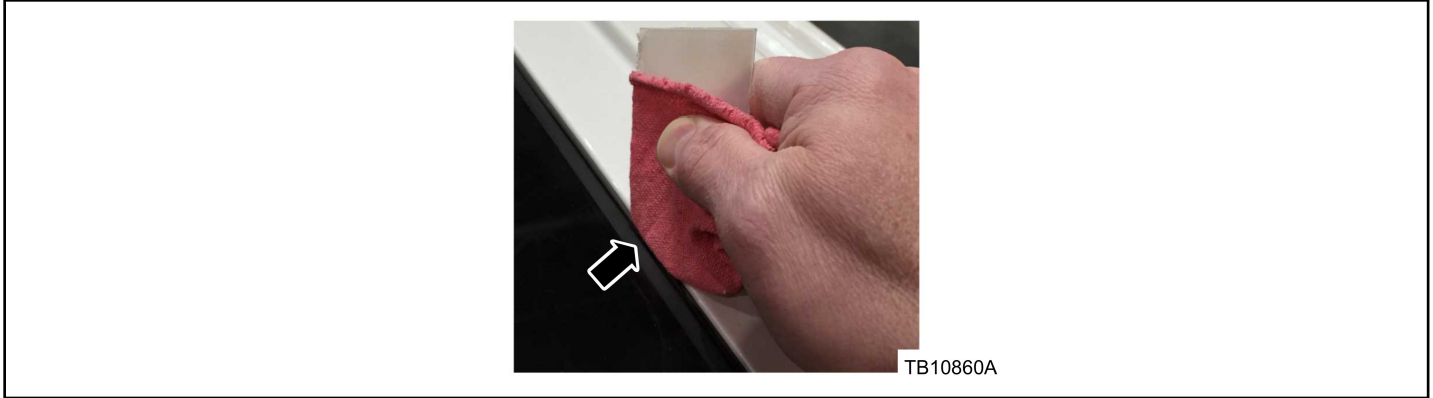
Figure 3 - Article 16-0020

7. Apply isopropyl alcohol onto a clean folded shop rag and insert it between the rear fixed glass panel seal and the roof opening sheet metal. (Figure 3)

- a. Folding the shop rag over a flexible piece of plastic such as an old credit card or a thin piece of plexiglass will assist in the cleaning process.
 - b. Slide the isopropyl alcohol-soaked shop rag around all sides of the fixed panel glass.
8. Apply a light film of Krytox® grease to the entire sheet metal roof opening of the movable glass panel and the front edge of the movable glass seal.
 9. Hold the wind deflector down and apply Krytox® grease to both openings of the left and right front set plates. (Figure 4)
