**FORD:**

2015 F-150

**ISSUE**

Some 2015 F-150 Lariat, Platinum and King Ranch vehicles equipped with climate controlled seats may exhibit a lack of cooling performance in the front seat backrests.

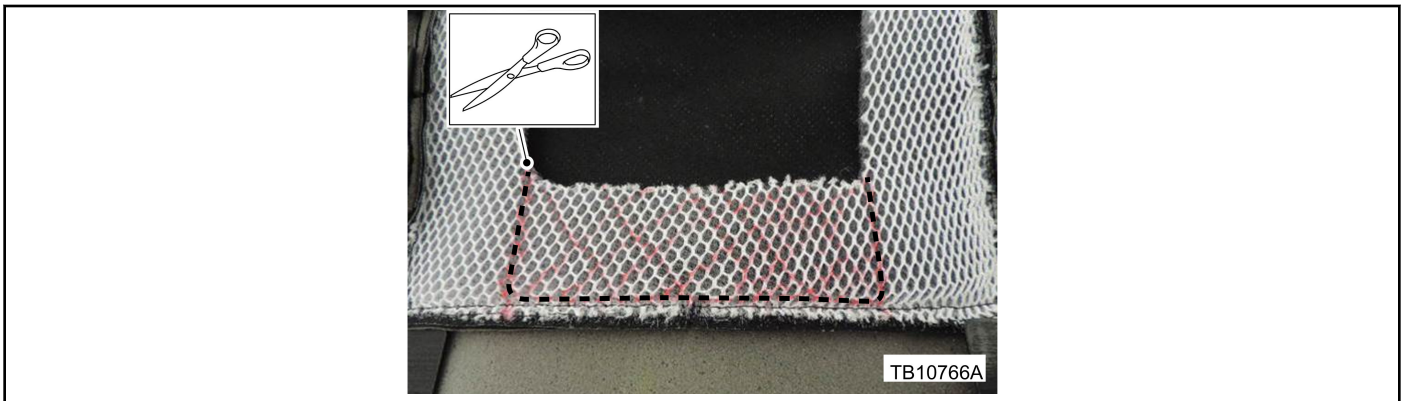
Figure 1 - Article 15-0154

1. Can the backrest blower motor be heard running when using the climate controlled seats?
  - a. Yes - proceed to Step 2.
  - b. No - this article does not apply. Refer to Workshop Manual (WSM), Section 501-10 for normal diagnostics.
2. Remove the front seat backrest blower motor. Refer to WSM, Section 501-10.
3. With the seat backrest cover positioned upward, use scissors or equivalent cutting device to remove the indicated portion of the seat backrest cover foam spacer pad (using the existing spacer pad opening as a guide). Do not cut the stitched seam at the lower edge of the seat backrest cover. (Figure 1)

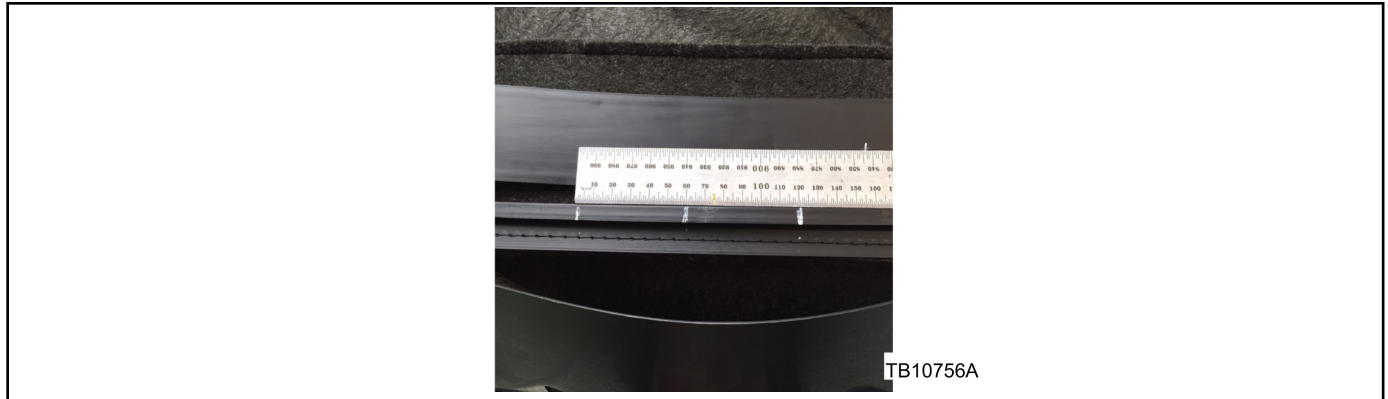
Figure 2 - Article 15-0154

4. Using a scale or equivalent measuring device, locate and mark the center of both seat backrest cover lower J-clips.
5. Measure 60 mm (2 3/8") from each side of the center mark on both J-clips and make two new marks.

- a. These new marks will be 120 mm (4 23/32") apart. (Figure 2)

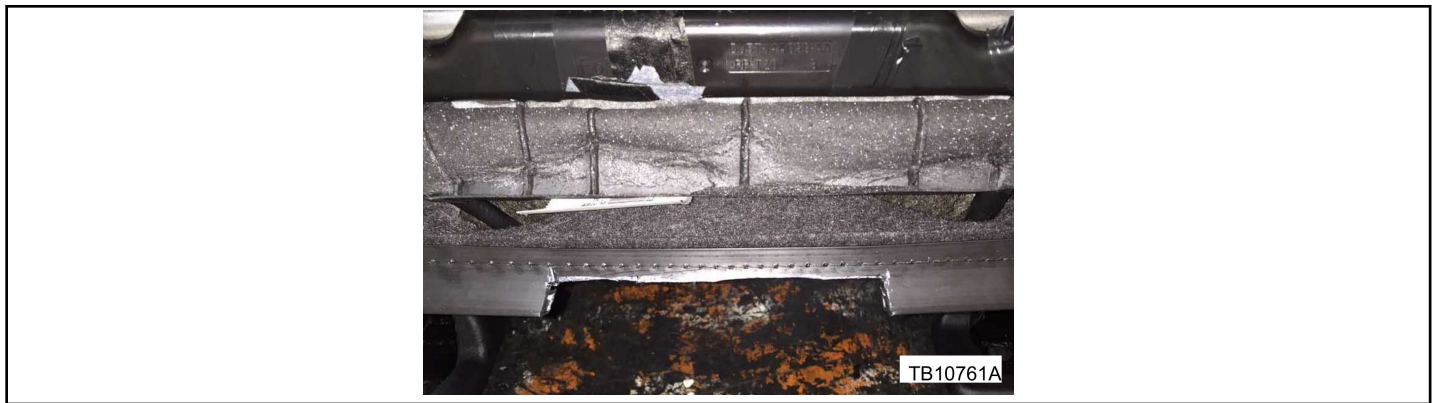
Figure 3 - Article 15-0154

- 6. Use diagonal cutting pliers or equivalent to remove the plastic J-clip section between these two new marks on both J-clips. (Figure 3)

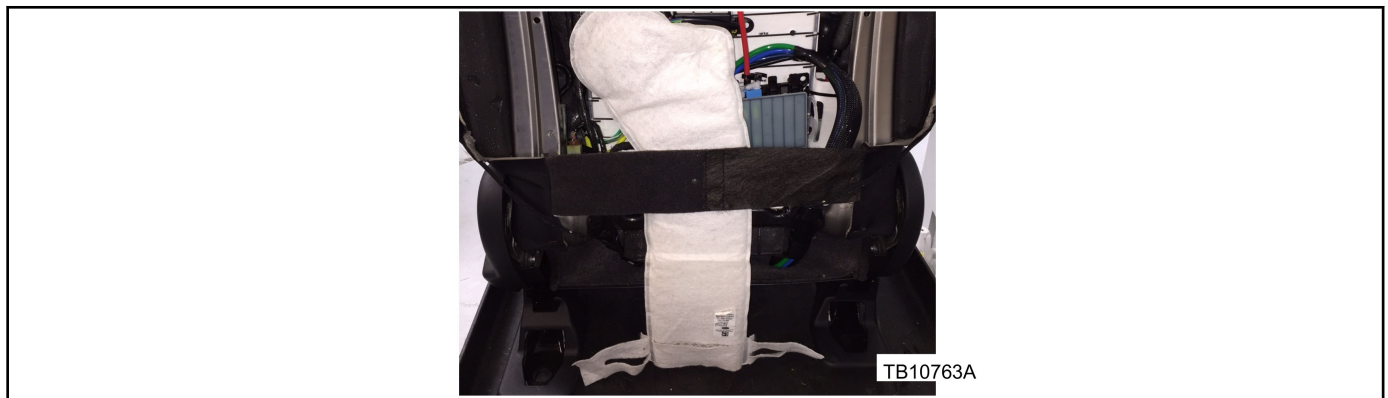
Figure 4 - Article 15-0154

- 7. Install the new seat backrest blower motor. Refer to WSM, Section 501-10.
  - a. Route the air intake snorkel of the new blower motor down and behind the hook-and-loop retainer strap. (Figure 4)

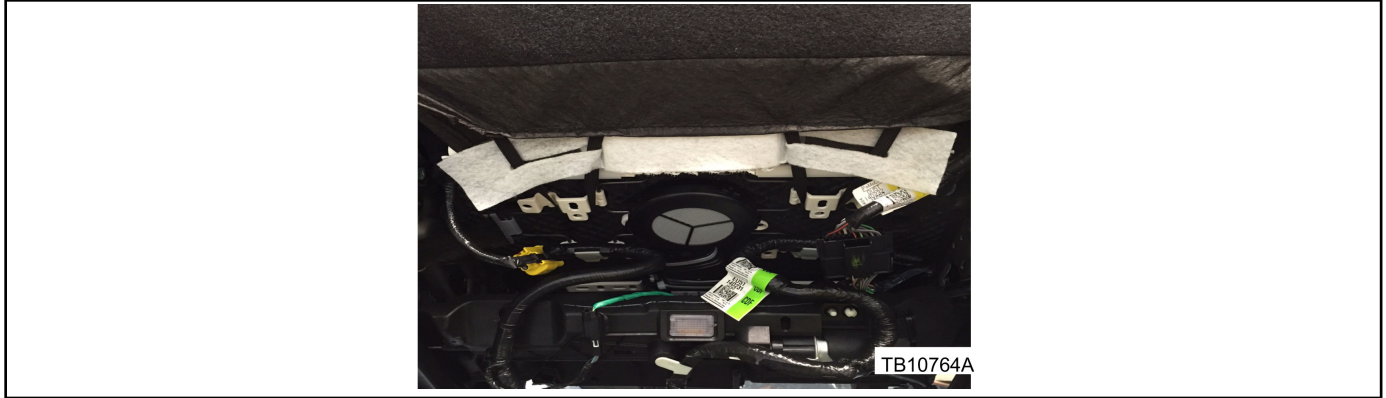
Figure 5 - Article 15-0154

- b. Route the elastic backrest cover straps through the slots in the fabric at the end of the air intake snorkel prior to refastening the elastic straps. (Figure 5)
