General Service Bulletin (GSB):	Paint Defects / Damage (Warrantable / Non-Warrantable)
GSB Overview:	Use this GSB to help determine (Warrantable / Non-Warrantable) Paint Defect / Damage
NOTE: This information is not intended to replace or supersede any warranty, parts and service policy, Work Shop Manual (WSM) procedures or technical training or wiring diagram information.

This GSB is designed to provide pictorial examples of paint defects / damage to assist in the warrantable / non-warrantable determination. Refer to the latest version of the Warranty and Policy Manual for paint defect warranty coverage.

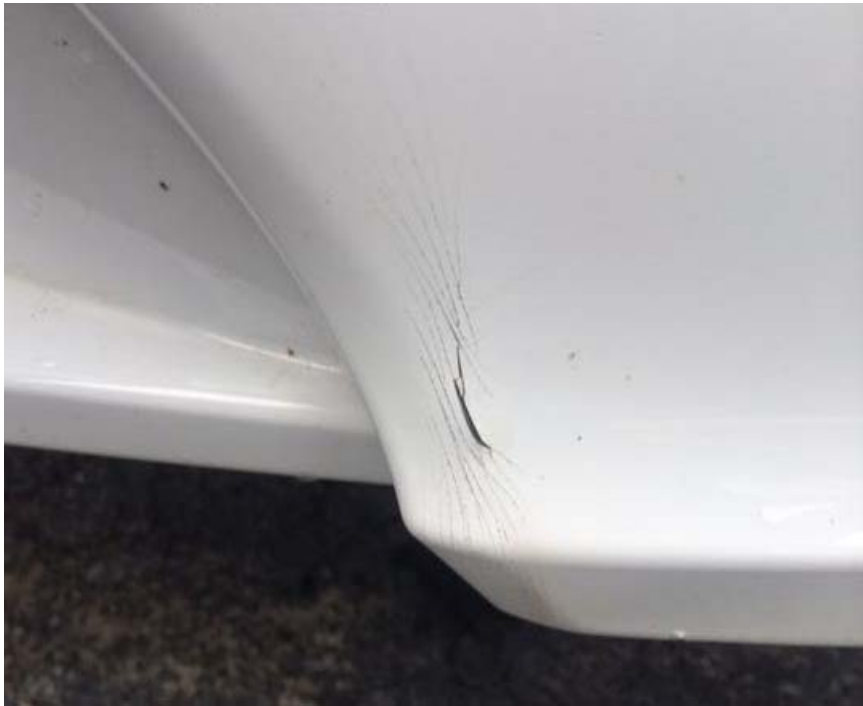
Cracked Paint

The cracks follow where the panel or bumper has been flexed. The pattern of cracks show the panel has been flexed causing the paint to crack.

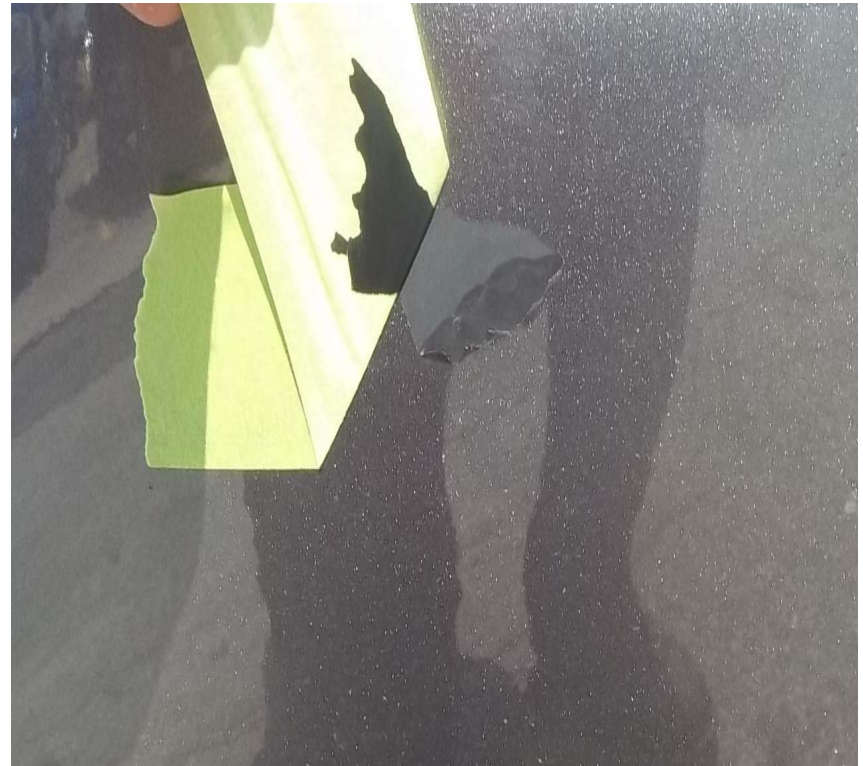
Paint Peeling (original factory paint)

NOTE: Paint Peeling is NOT Warrantable if it originates from damage, i.e. dents, dings, chips, or scratches or is not the original factory paint.

The lifting edges of the paint show that the paint is not adhering properly to the panel. A tape test (refer to Tape Test in the reference section) would determine if a defect is present. Paint will be removed in a large sheet showing a primer surface.

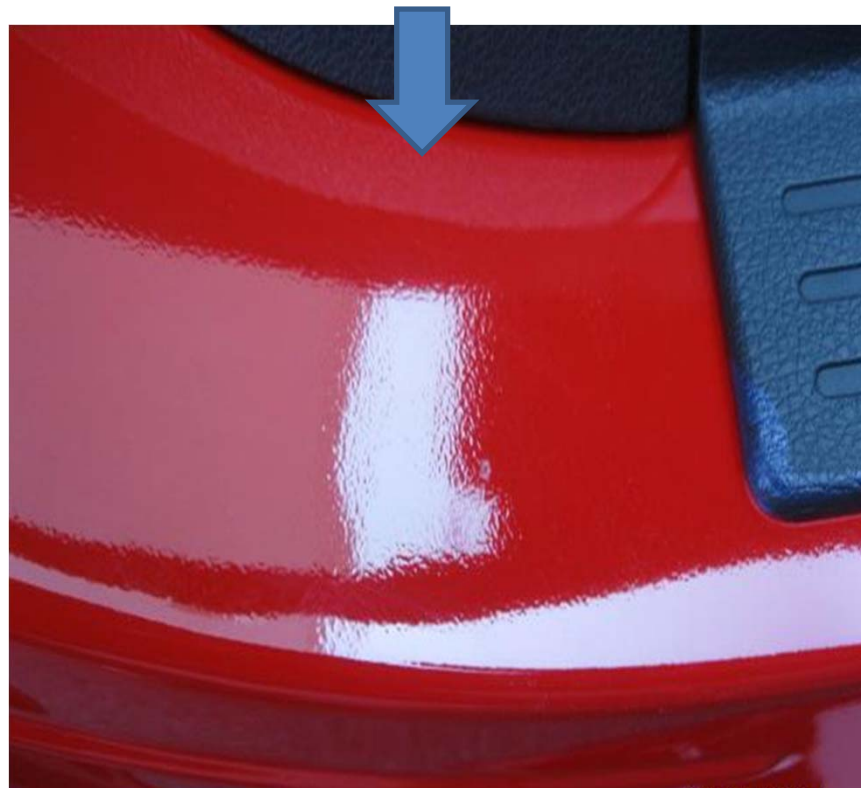
Orange Peel (Original Factory Paint)

Orange peel will appear dull and spotty. Objects in the reflection of the paint will not be able to be identified.

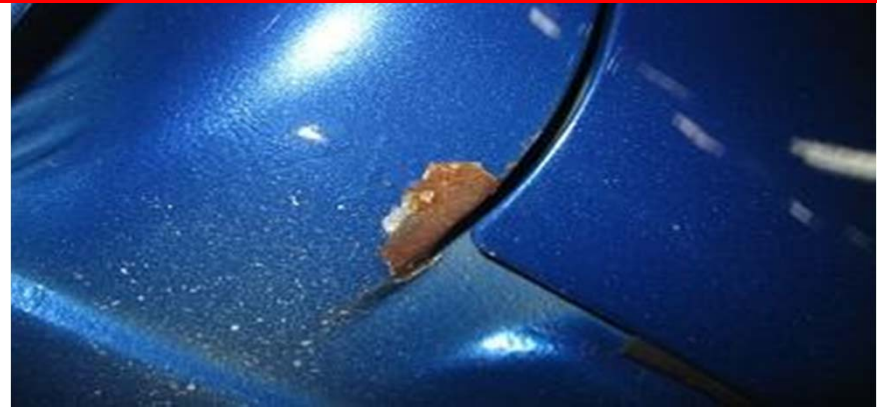
**Surface Corrosion (Original Factory Paint)
Covered under the New Vehicle Warranty**

Body sheet metal that has corrosion damage without perforation

Note: Corrosion that develops from a paint chip or impact to the finish is not warrantable.

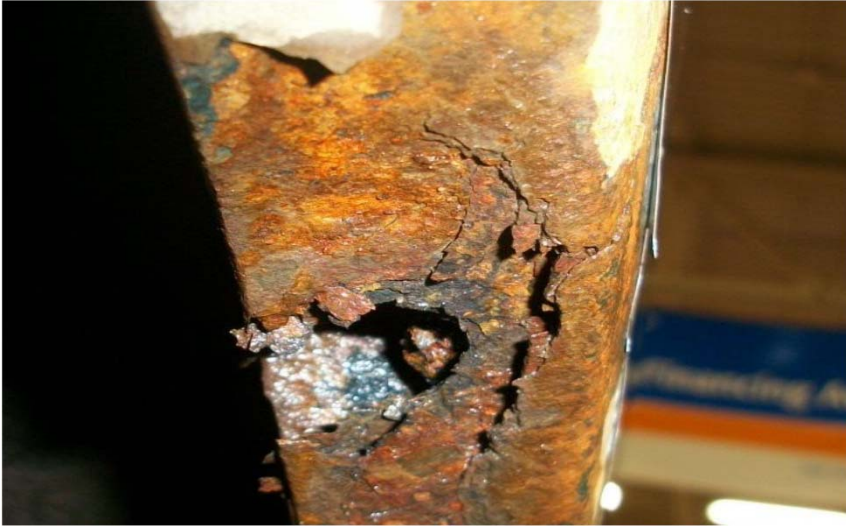
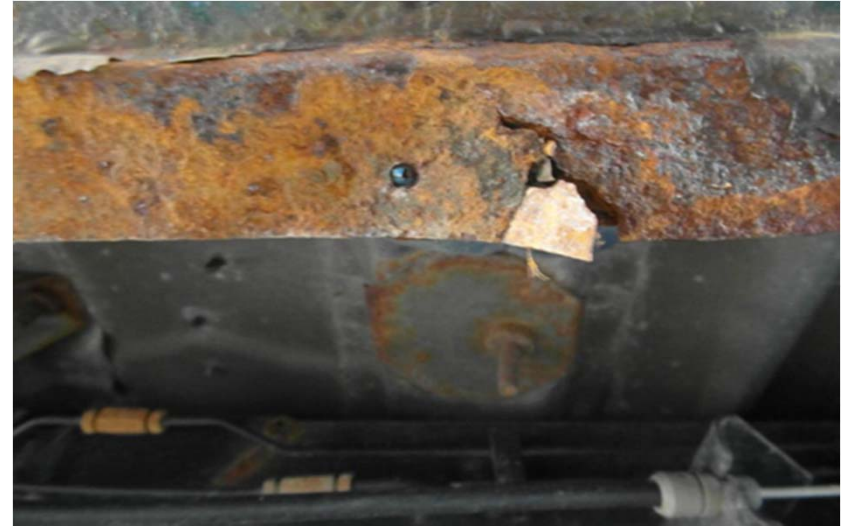
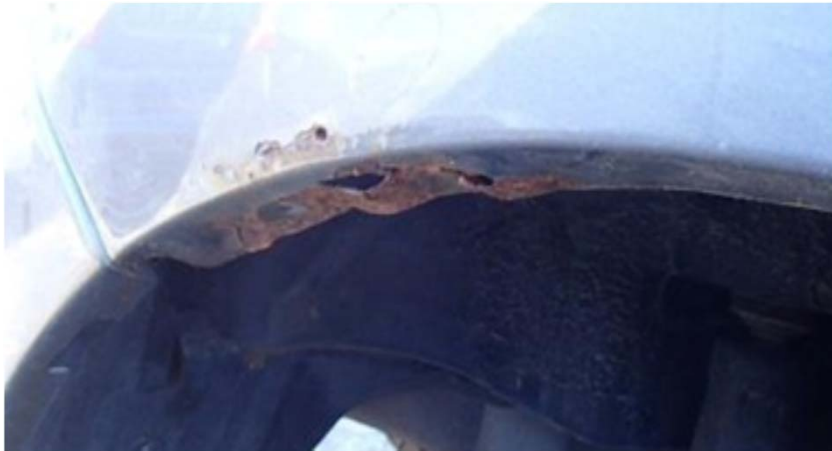
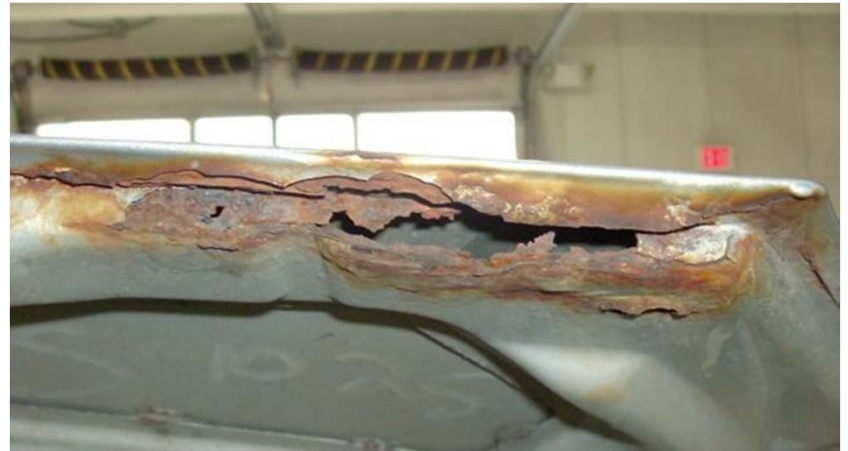
Sheet Metal Perforation

Covered under the Corrosion Warranty
