TSB 16-0155

2015-2017 F-150

ISSUE

Some 2015-2017 F-150 vehicles may exhibit inoperative latches on front doors and/or SuperCrew rear doors during freezing temperatures.

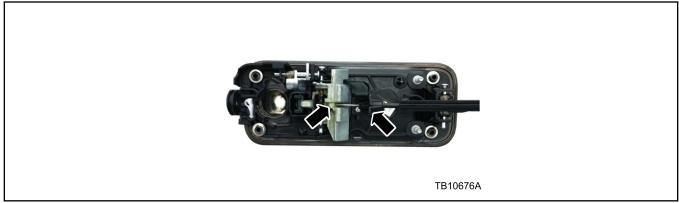
Figure 1 - Article 16-0155

- 1. Remove both front door interior door panels on all vehicles and both rear door interior door panels only on SuperCrew vehicles. Refer to Workshop Manual (WSM), Section 501-05.
 - a. Remove door water shield for access.
 - b. Verify the latch release cable is properly seated and the cable end is properly installed on to the outer handle. (Figure 1)

- If improper installation is found and the cable has become kinked, the cable should be replaced. Refer to WSM, Section 501-14.
- Remove both front door latch assemblies on all vehicles and both rear door latch assemblies only on SuperCrew vehicles. Refer to WSM, Section 501-14.
- 3. Use compressed air to blow dry all the door latch assemblies after removal and all interior handle assemblies.
- Replace the door latch retaining brackets. Refer to WSM, Section 501-14.

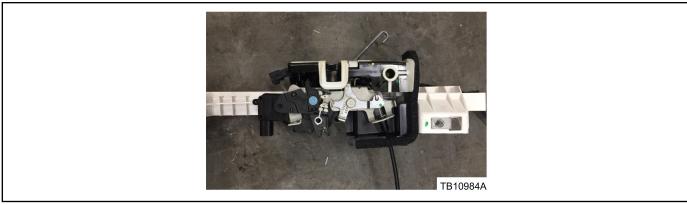
Figure 2 - Article 16-0155

a. Install the rain shield on the door latch brackets opposite the latch using the supplied hardware. (Figure 2)
