Ford SCME Ground Wire Repair and Modification

Author: Bill Rowe

Dated: 09-Feb-20

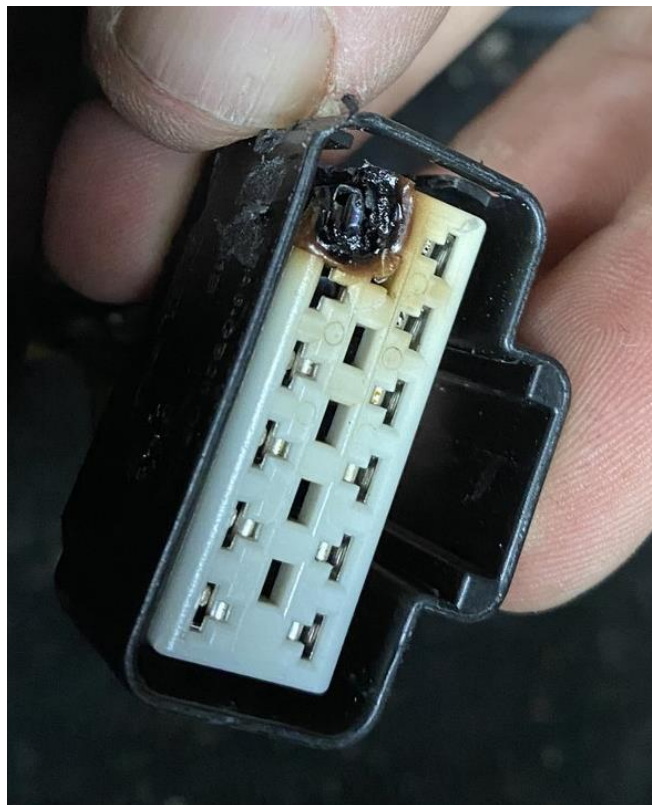
Figure 7 - Terminal Side of Connector with Failure

The larger C3265A connector should be inspected for any damage, even if your seat heaters are working. Figure 6 shows what to look for on the wire out end of the connector while Figure 7 shows a typical failure on the terminal side. Notice the discoloration of the BL-BU ground wire at Position M.

The above picture is typical of what the connector will look like after a failure. Figure 8 shows the damage to the outside of the module. This damage residue will need to be removed as part of the operation.

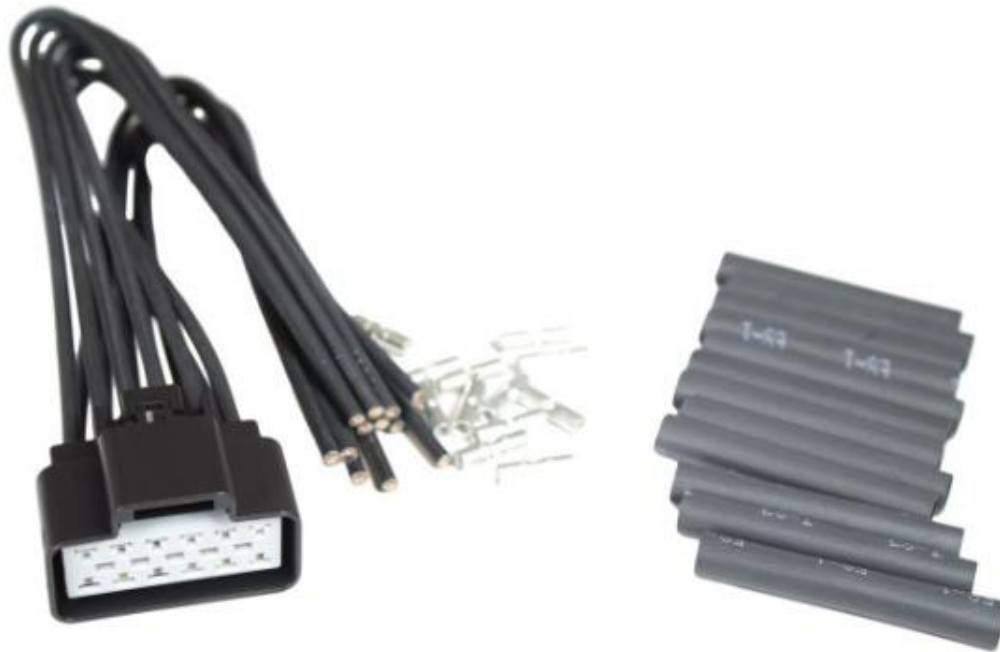
Figure 14 - Motorcraft WPT-928 Package Contents

The pigtail is available from a variety of suppliers under the Ford P/N 3U2Z-14S411-ZMB or Motorcraft P/N WPT-928. The package includes crimp connectors and heat shrink tubing to facilitate splicing in the new wires with pre-crimped terminals along with an instruction sheet. This is handy if you do not have a proper terminal crimper. Figure 14 shows the components of the package.
