<b>Connector:</b> <b>C9039</b>	<b>Description</b> AUTO-DIMMING INTERIOR MIRROR	<b>Color</b> BK	<b>Harness</b> 14358	<b>Base Part #</b> 17700	<b>Service Pigtail</b> Not Available
-----------------------------------	--	--------------------	-------------------------	-----------------------------	---

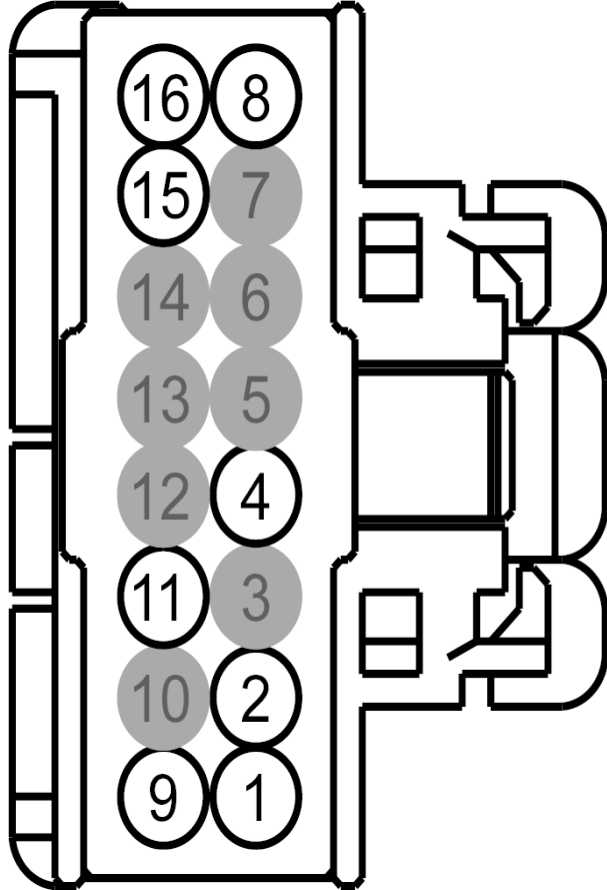
Pin	Circuit	Gauge	Circuit Function	Qualifier
1	CBP32 (GN-VT)	18	FUSE - 32 OR CIRCUIT BREAKER	
2	VDN01 (BU-WH)	20	CTRL MOD. - LIN BUS # SPDJB 1	
3	*	*	Not Used	
4	GD133 (BK)	20	GROUND - COWL SIDE/PILLAR A LEFT (6L2T)	
5	*	*	Not Used	
6	*	*	Not Used	
7	*	*	Not Used	
8	VMP19 (WH-GN)	20	CAMERA - PARKING AID REAR VIDEO	
9	CLS28 (BU-WH)	20	CTRL MOD. - RELAY REVERSE LAMP CONTROL (RLC)	
10	*	*	Not Used	
11	LRD12 (BU-GY)	22	CTRL MOD. - ELECTROCHROMIC MIRROR	
12	*	*	Not Used	
13	*	*	Not Used	
14	*	*	Not Used	
15	RRD12 (BN)	22	CTRL MOD. - ELECTROCHROMIC MIRROR	
16	RMP19 (BN-VT)	20	CAMERA - PARKING AID REAR VIDEO
