## SERVICE PROCEDURES (Continued)

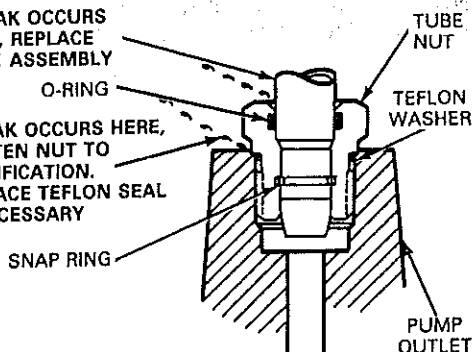
G7237-B

NOTE: IF LEAK OCCURS  
HERE, REPLACE  
HOSE ASSEMBLY

NOTE: IF LEAK OCCURS HERE,  
TIGHTEN NUT TO  
SPECIFICATION.  
REPLACE TEFLON SEAL  
IF NECESSARY

NOTE: ALWAYS REPLACE  
THIS SEAL WHEN A  
LINE IS REMOVED
