It's my first day!

Don't waste money to retrofit Sync 3 hardware as of 2021. Instead, retrofit Sync 4. If you decided to install old Sync 3 parts then proceed.

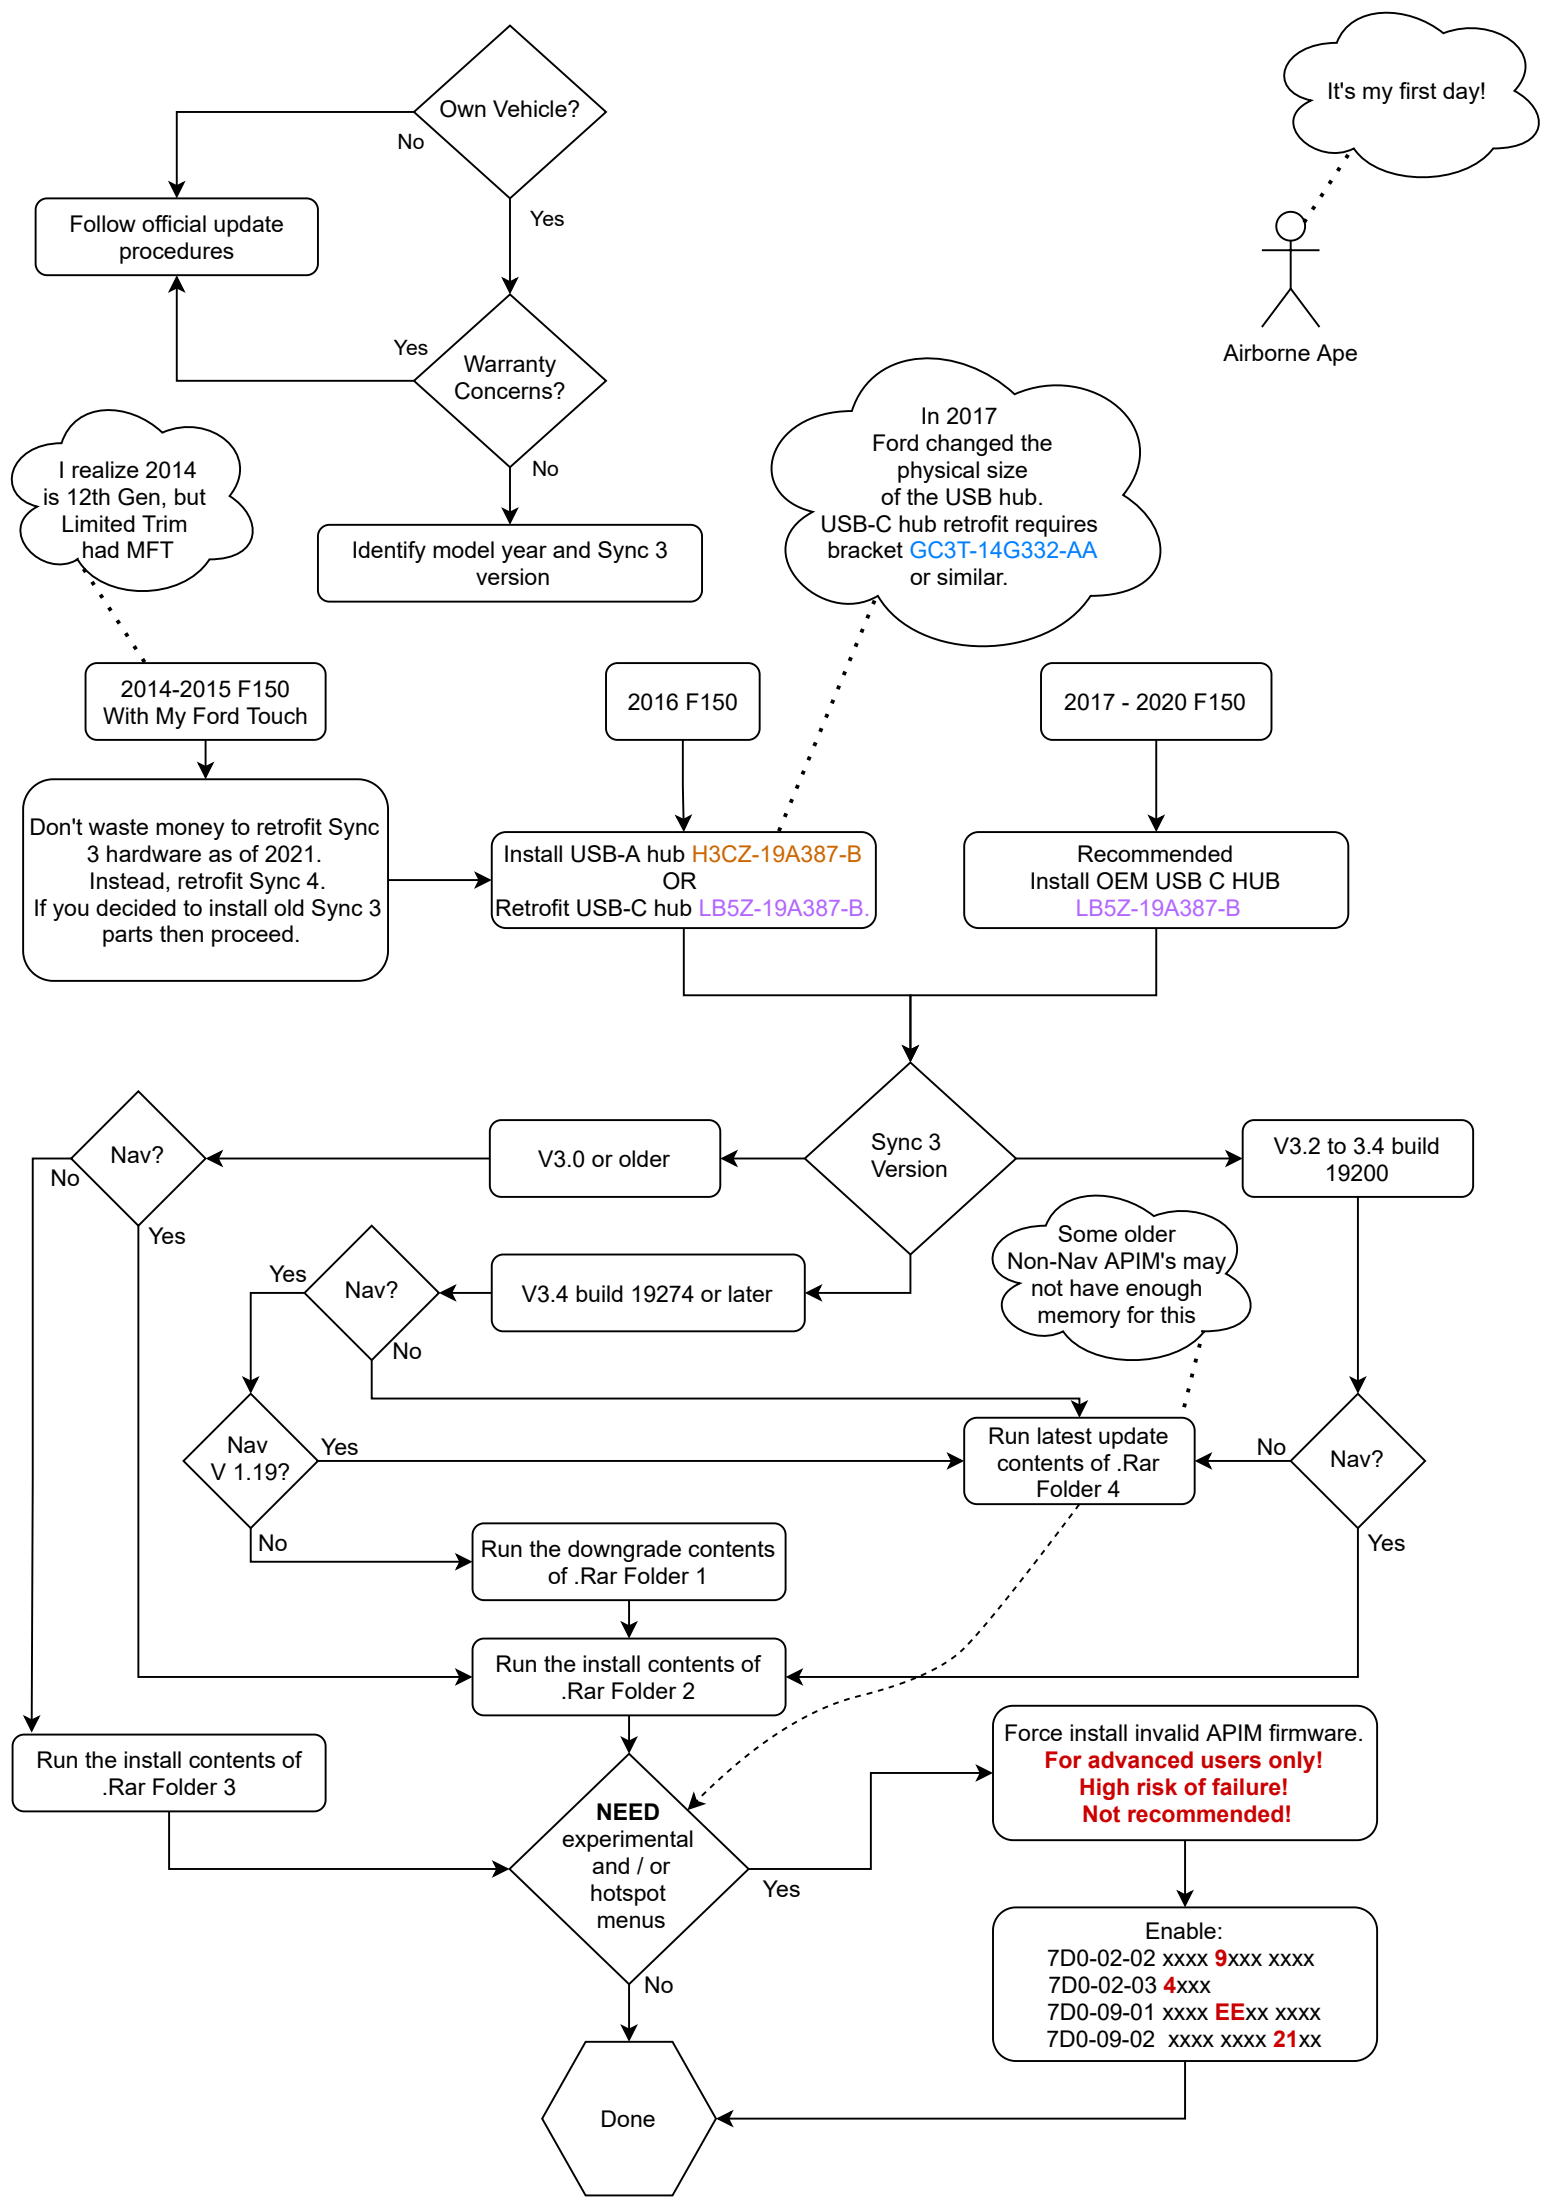
I realize 2014 is 12th Gen, but Limited Trim had MFT

In 2017 Ford changed the physical size of the USB hub. USB-C hub retrofit requires bracket GC3T-14G332-AA or similar.

Some older Non-Nav APIM's may not have enough memory for this

Force install invalid APIM firmware. For advanced users only! High risk of failure! Not recommended!

Enable:
7D0-02-02 xxxx 9xxx xxxx
7D0-02-03 4xxx
7D0-09-01 xxxx EExx xxxx
7D0-09-02 xxxx xxxx 21xx
