2015/16 XLT 302A Halogen to Non-King Ranch LED Tail Lamp Conversion

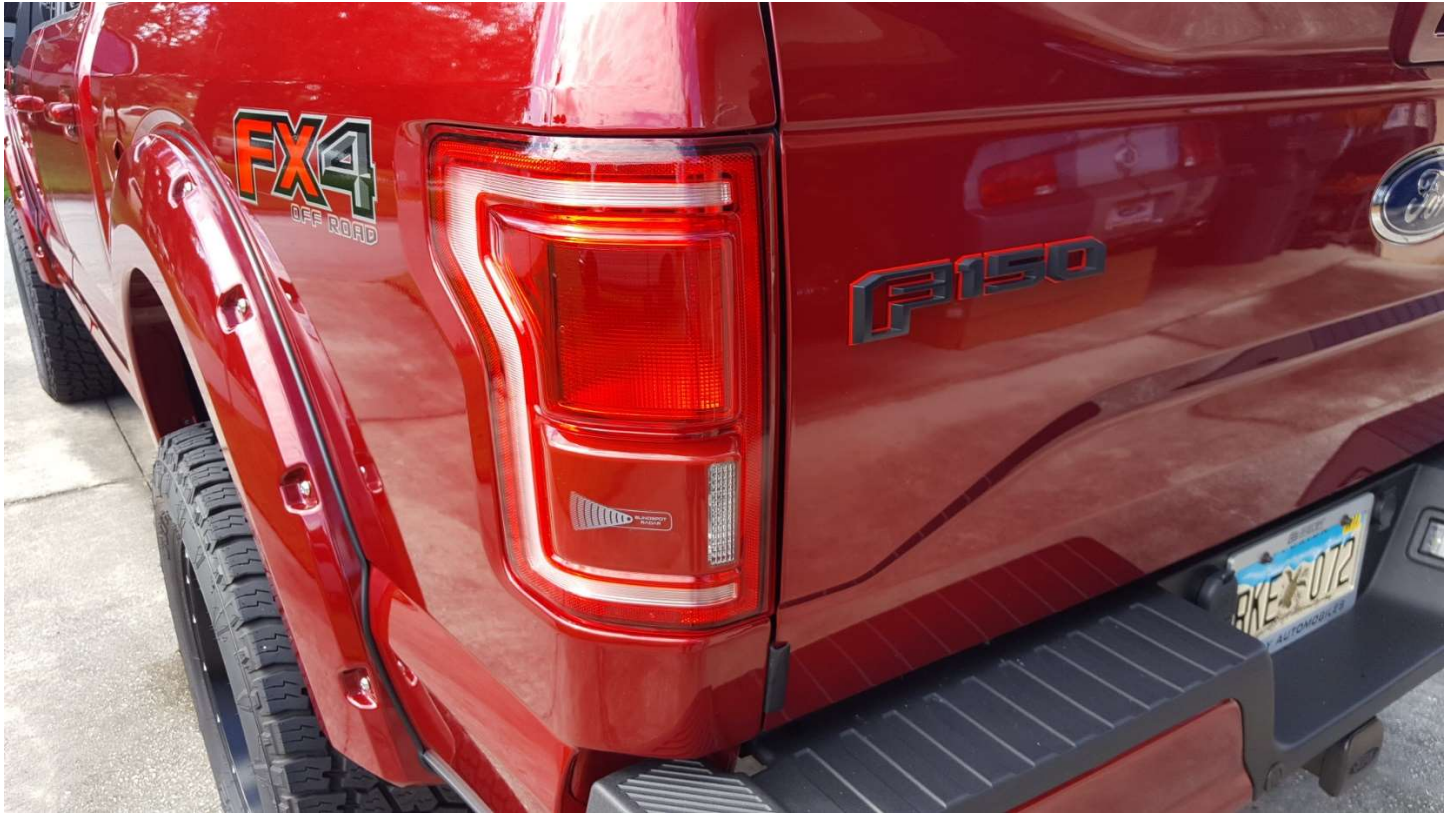
2015 thru 2017 Non-King Ranch LED Tail Lamps

- LED Tail Lamps - LED tail lamp does **NOT** include BLIS module, mounting bracket or hardware
 - 2015 thru 2017
 - (1) HL3Z-13404-D Non-King Ranch LED w/BLIS Tail Lamp As. - RH (has a \$50 core charge)

- (1) HL3Z-13405-D Non-King Ranch LED w/BLIS Tail Lamp As. - LH (no core charge)
 - or**
 - 2018
 - (1) JL3Z-13404-F Non-King Ranch LED w/BLIS Tail Lamp As. - RH (has a \$50 core charge)

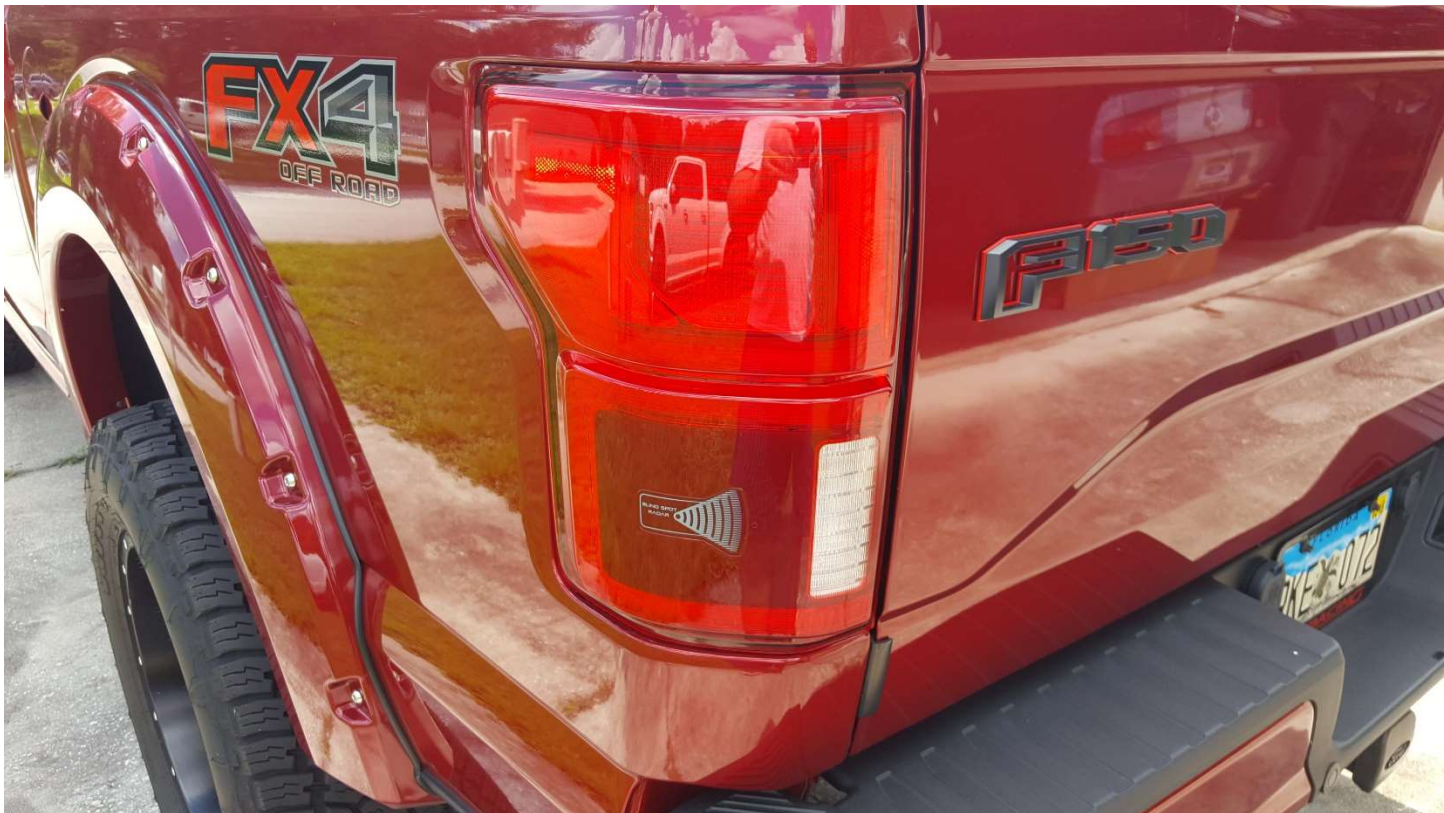
2018 Non-King Ranch LED Tail Lamps

- (1) JL3Z-13405-F Non-King Ranch LED w/BLIS Tail Lamp As. - LH (has a \$50 core charge)
- (2) 6.5" x 4.5" x 1/8" pieces of plexiglass (or Lexan) and silicone to fabricate covers for the BLIS module opening.
