***Gas Engine
Performance
Modifications Job
Aid***

**A Guide to Identifying Failures Related to
Performance Modifications**

Introduction

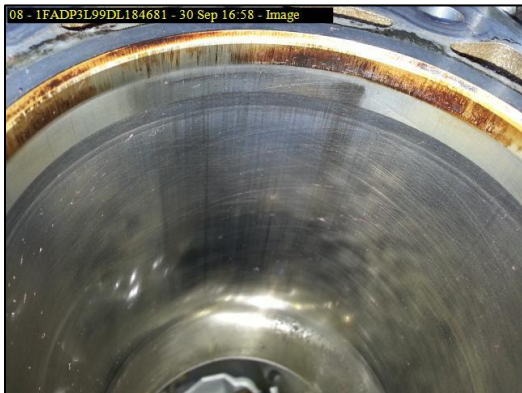
Figure 2: Scored Bore Walls

Description: Damage to piston profiles can often be attributed to pre-ignition (knock) events. OEM calibrations will protect the engine from pre-ignition damage by retarding spark. Aftermarket calibrations will typically change timing schedules and allow the engine to run closer to damage limits. Pre-ignition along with extreme air-fuel ratios and excessive oil consumption may also damage catalyst material. This material can then be pulled back into the engine, scoring the cylinder bore walls.

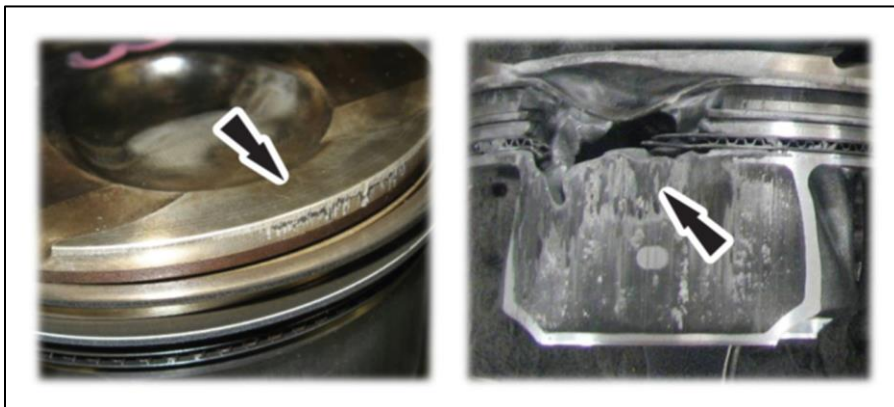
Figure 3: Light/Heavy Knock Damage

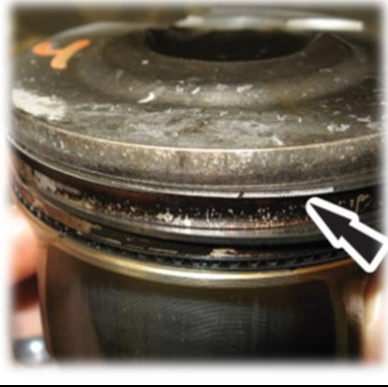
Figure 5: Piston Ring Damage

Description: Damage to the top piston ring may exhibit in the form of delamination or pitting.

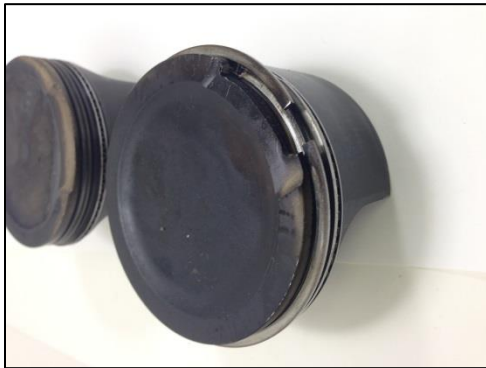
Figure 6: Ring Land Damage

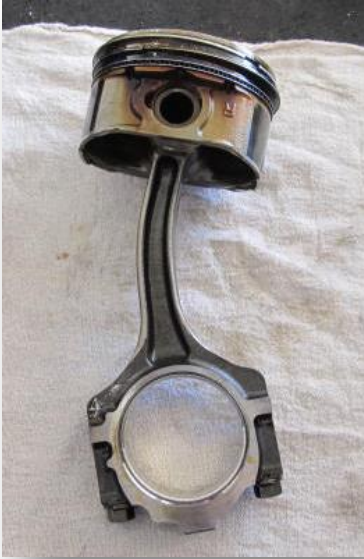
Figure 7: Bent Connecting Rod from Hydrolock

Description: Hydrolock occurs when a volume of liquid greater than the smallest volume of the combustion chamber enters the cylinder and becomes incompressible as the piston reaches TDC. The result is most commonly a bent or broken connecting rod. Rod damage may also be caused by excessive cylinder pressure (overboost condition) and may not be obvious via visual inspection. Rod twisting can lead to bore scoring and eventual piston failure. Note that rod bends or twists may not be obvious visually, but can still contribute to engine damage or failure.

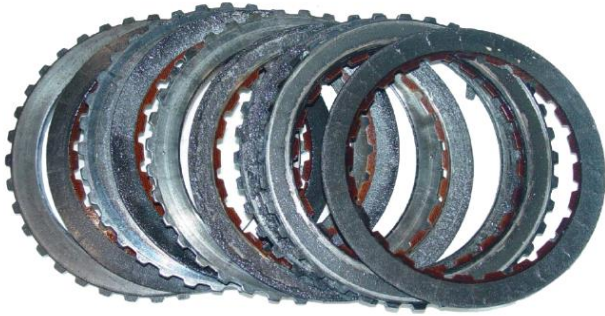
Figure 9: Damaged Clutch Discs

Description: Clutch damage can present itself in many forms including discoloration, cracking, and warping of the clutch discs and separator plates.

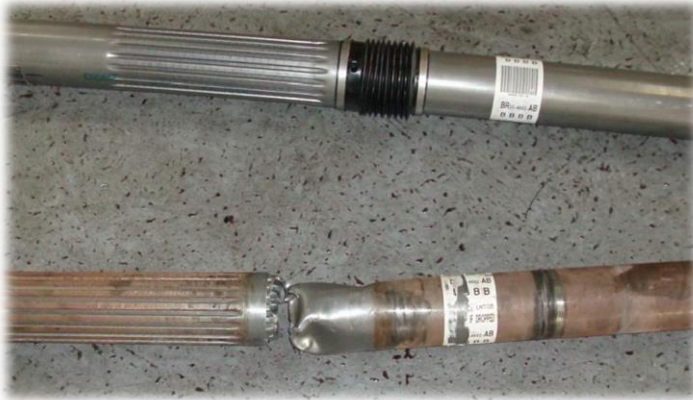
Figure 11: Twisted Driveshaft

Description: Twisting of the driveshaft is commonly associated with increased torque output.

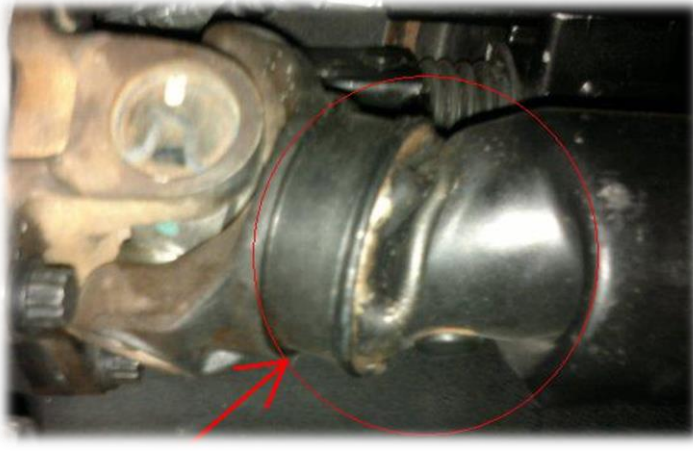
Figure 12: Twisted Driveshaft

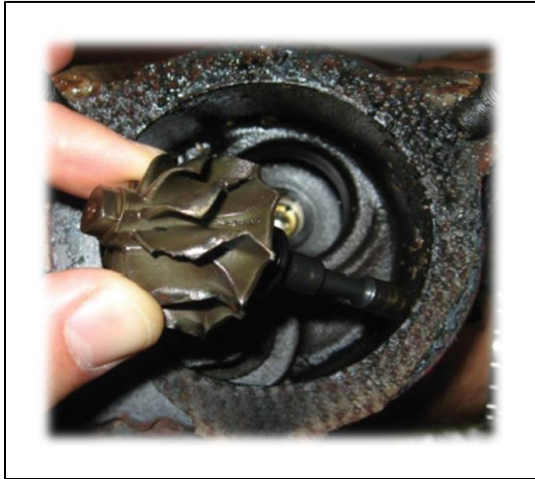
Figure 13: Compressor Blade Damage from Overspeed Event

Description: Turbo compressor damage is commonly identified by broken or deformed turbine blades.

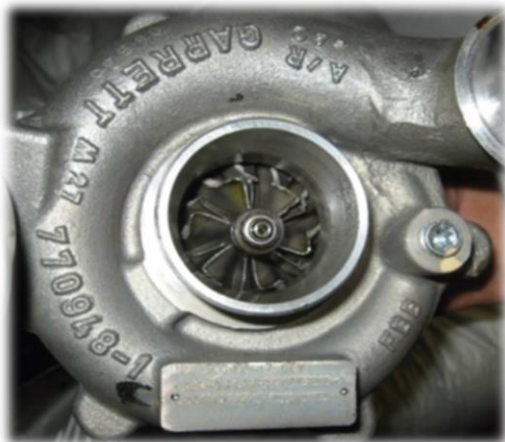
Figure 14: Compressor Blade Damage from Overspeed Event

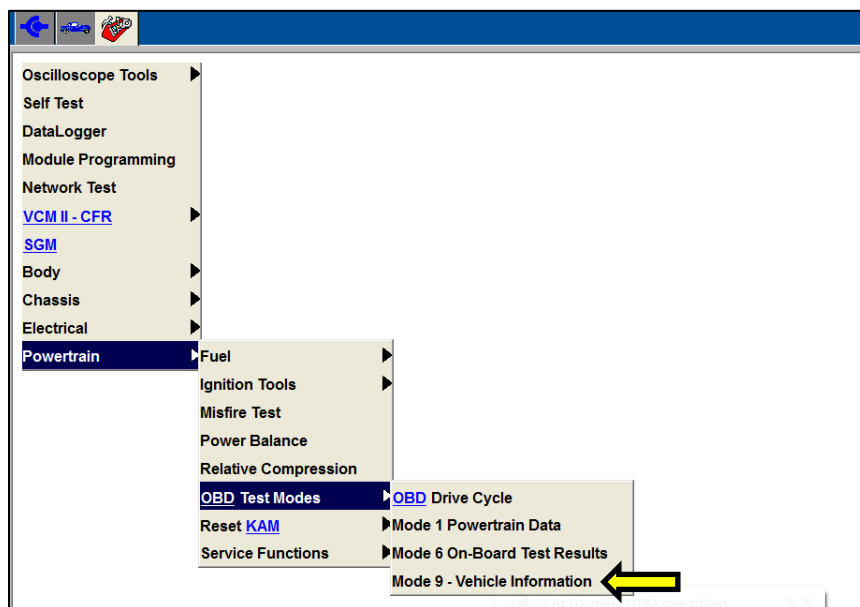
Figure 15: Mode 9 Data

2. View calibration file name in Mode 9 Data.
3. Look for any abnormalities in calibration file name and/or revision level.
4. Refer to the Service Repair and Technical Assistance Process document for help in determining the correct calibration name, if needed.

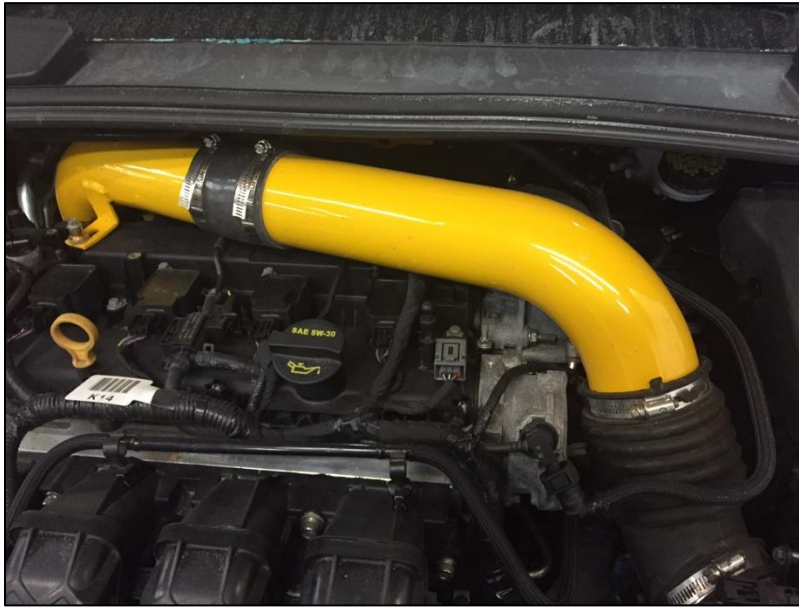
Figure 18: Aftermarket Air Intake

Description: Modifications to the air intake system may include aftermarket air boxes, filters and low/high pressure air ducts. The system may be particularly susceptible to flexible air ducts between the air filter and the compressors. Restrictions on either side of the compressor can result in over-speeding the turbo in forced induction engines. Aftermarket air induction systems may cause lean air-fuel ratio DTC's (P0171 & P0174).

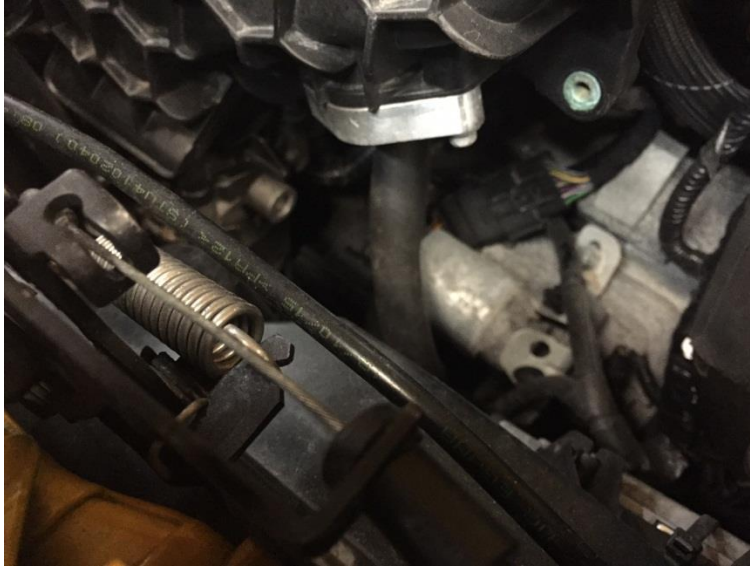
Figure 19: PCV Block off Plate

Description: PCV systems that are modified (vented to atmosphere being the most common modification) can result in a condition where oil gets past the turbine seal even on an undamaged, fully functional turbocharger. Oil in the exhaust system may not be sufficient evidence to identify a failed turbo if the PCV system has been compromised. Modified PCV systems, however, are often good indicators that other engine modifications may be present.

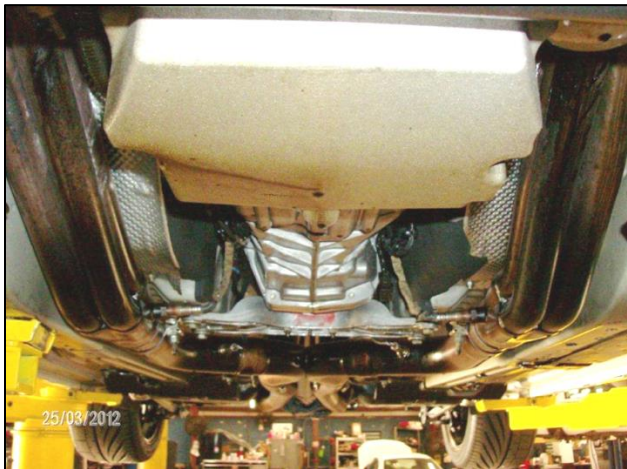
Figure 22: Long Tube Headers - Catalyst Delete and "X" pipe

Description: Common modifications include the removal of catalysts, mufflers and resonators. In turbocharged applications modifications to the exhaust system can reduce backpressure and may result in over-speeding the turbo(s). In some cases a good indicator of an aftermarket exhaust is the presence of additional clamps (Figure 21). Visually compare installed exhaust to pictures of OEM exhaust, if necessary.

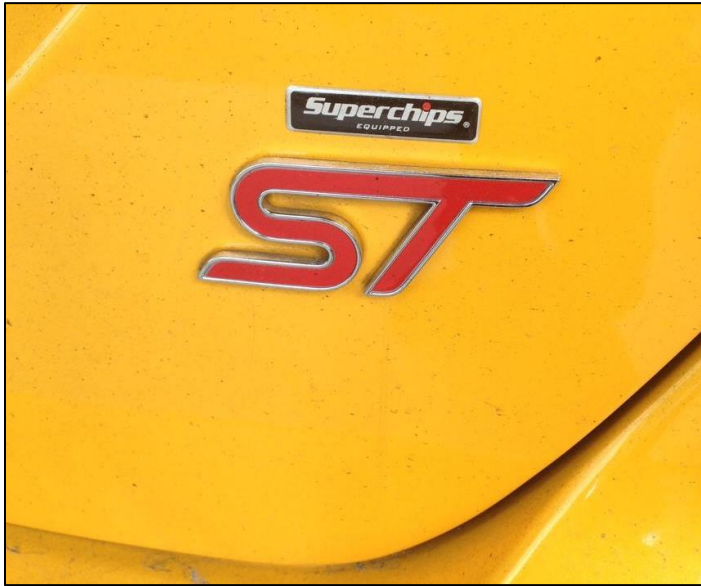
Figure 23: Aftermarket Badge

- Indicator of possible aftermarket modifications present
 - Inquire with customer as to existence of said aftermarket parts
-

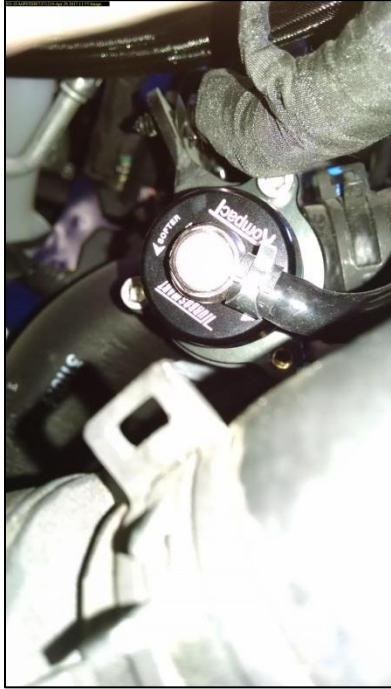
Figure 25: Typical Blowoff Valve

Description: Blowoff valves relieve intake manifold pressure to prevent turbo compressor surge. When the pressure is released a distinct hissing sound can be heard. Blowoff valves are often tuned for their auditory effect. In doing so, the amount of pressure relieved from the system can change leading to compressor surge.

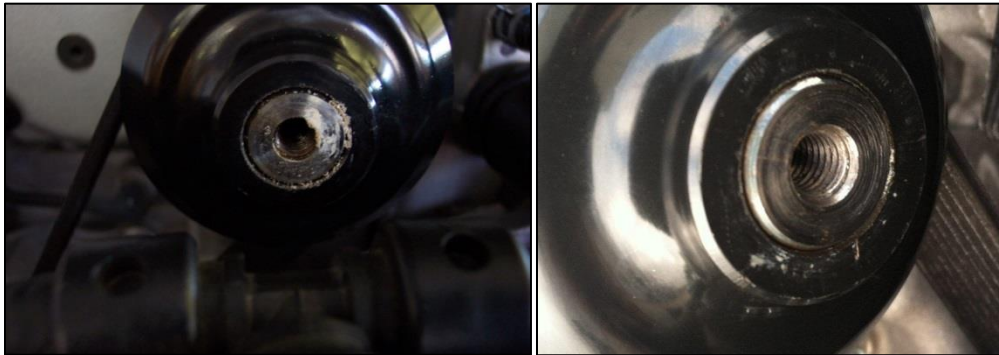
Figure 27: OEM Drive Pulley | Left: Untampered | Right: Tampered With

Description: Customers may modify or replace supercharger drive pulleys to increase supercharger speed and associated boost pressure. Customers may reinstall the OEM drive pulley before bringing the vehicle in for repair. Figure 27 shows both untampered and tampered with pulleys. On the left side of Figure 27, note the white anti-tamper compound and smooth face of the blower shaft. The black plastic cover is an X-mas tree style and can be removed by unscrewing it from the blower shaft. On the right side of Figure 27, note the white anti-tamper compound is almost all removed and is misaligned (12 o'clock on shaft and 3 o'clock on pulley). Gall marks on the face of the blower shaft and scuff marks on the face of the pulley indicate use of a puller to remove the pulley and a press tool to reinstall the pulley. The most common change is a smaller diameter drive pulley to increase boost by spinning the blower at higher RPMs. This modification also requires a PCM aftermarket tune. The OEM pulley is 2.6 inches in diameter. Most aftermarket pulleys are 2.4 inches in diameter.

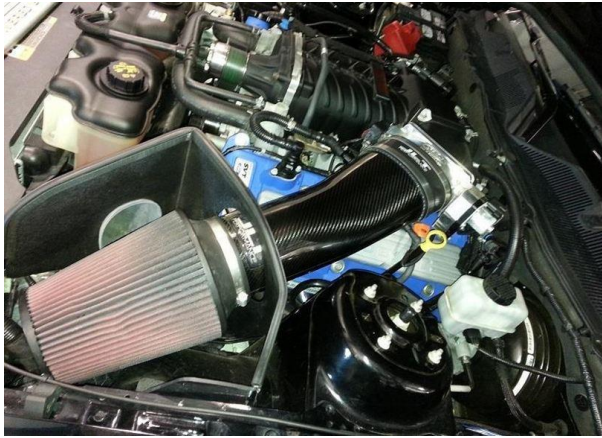
Figure 28: GT500 Aftermarket Air Filter, Inlet Tube, Throttle Body & Supercharger

Description: Adding aftermarket superchargers can stress the engine beyond design limits through increased torque and power outputs and cause numerous failures. Changes in the induction system such as aftermarket throttle bodies and inlet tubes can cause changes in air-fuel ratio that leads to piston damage. These modifications should be easily visible. Most aftermarket superchargers will have a custom surface finish (polished or wrinkle black).

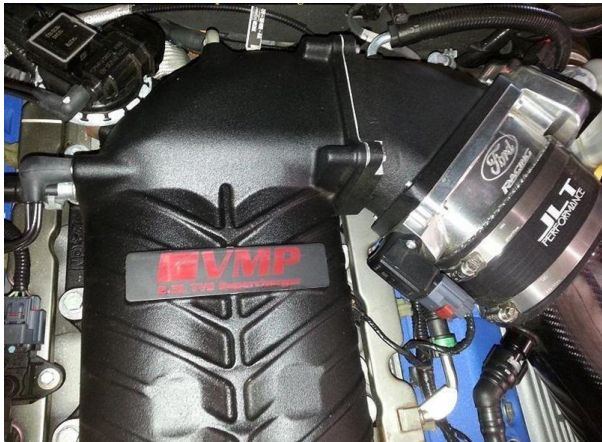
Figure 29: GT500 Aftermarket Supercharger & Throttle Body
