19-7027 27 March 2019

GENERAL SERVICE BULLETIN Parking Aid Sensor Diagnoses With No DTCs Present

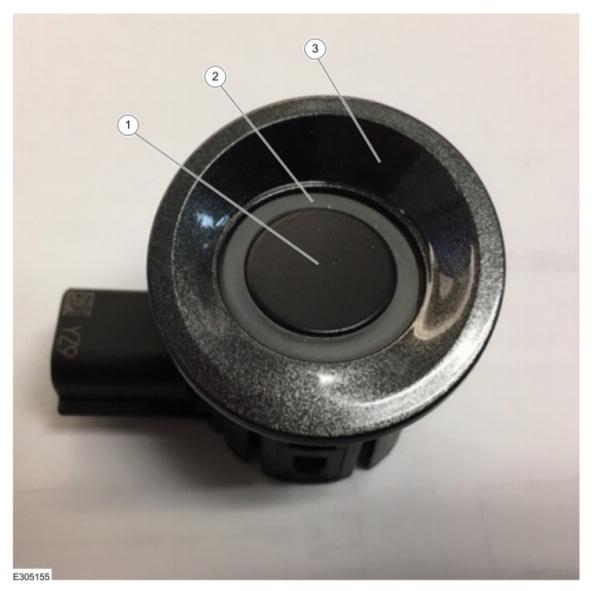
Figure 1

Item	Description
1	Park aid sensor
2	Park aid silicon ring
3	Park aid retainer

The purpose of the silicon ring (Figure 1 Callout 2) is to absorb vibrations and thus reduce false alerts. A thin film of ice may bridge over the silicon ring and/or sensor (Figure 1 Callout 1) and false alerts can occur. Upon visual inspection there maybe no obvious obstruction with the sensor. Often, when the vehicle is brought into the service bay, the ice will melt and all evidence of frost/ice would no longer be present.

Diagnostics should be performed but if no DTCs are present then ice bridging on the sensor was likely the issue. Verify sensor alignment and ring placement is symmetrical. Refer to the Workshop Manual (WSM) for diagnostics.

If no issues are found, advise the customer that this is a normal vehicle characteristic. Advise the customer they have the ability, on some vehicles, to turn the park aid system off in certain weather conditions.
