This article supersedes TSB **08-1-9** to update Vehicle Applications, Service Procedure and Part List.

ISSUE

Some 2004-2008 F-150, 2006-2008 Mark LT, 2005-2008 F-Super Duty, Expedition, and Navigator, with 5.4L 3-V engine; 2005-2008 Mustang, 2006-2008 Explorer, Mountaineer, and 2007-2008 Explorer Sport Trac with 4.6L 3-V engine; 2005-2008 F-Super Duty, 2006-2008 and F-Stripped Chassis, with 6.8L 3-V engine may experience difficulty with spark plug removal. This may cause damage to the spark plug and leave part of the spark plug in the cylinder head. Affected engine build dates are as follows: 5.4L 3-V and 6.8L 3-V before 10/9/07, 4.6L 3-V before 11/30/07.

Spark Plug Removal Procedure

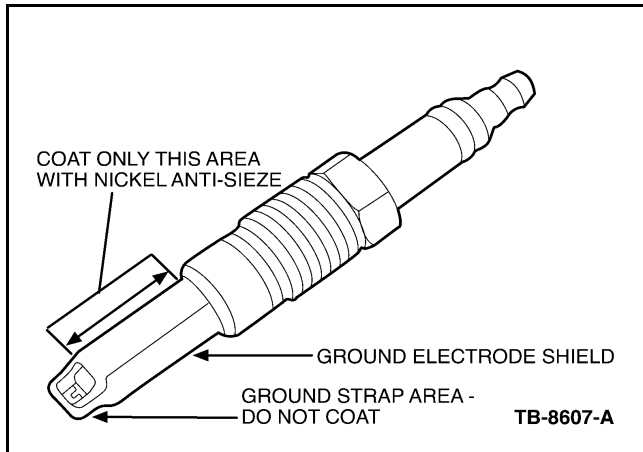
Figure 1 - Article 08-7-6

NEW PLUGS SHOULD BE INSTALLED USING A FILM COATING OF MOTORCRAFT HIGH TEMPERATURE NICKEL ANTI-SEIZE LUBRICANT ON THE GROUND ELECTRODE SHIELD. DO NOT COAT THE ELECTRODE STRAP. (Figure 1)

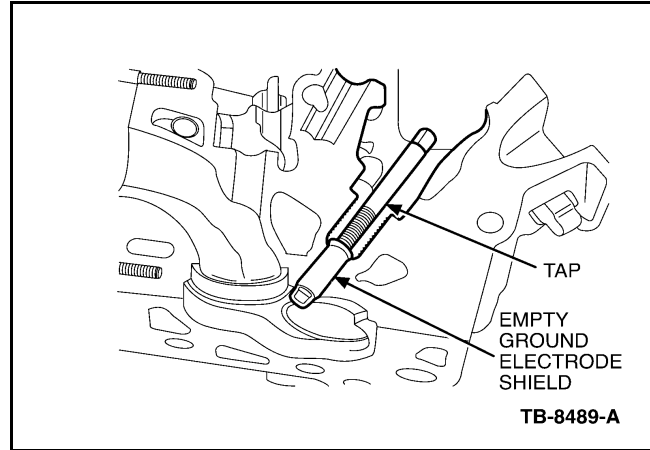
Figure 2 - Article 08-7-6

- a. Mode 1: The ground electrode shield is left behind as an empty shell. (Figure 2)

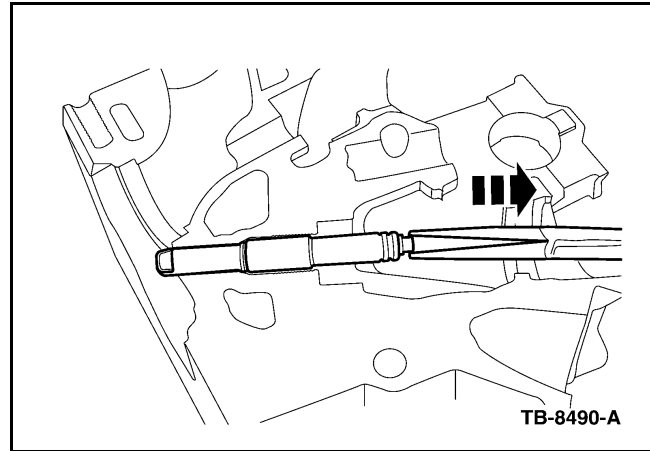
Figure 3 - Article 08-7-6

- b. Mode 2: The entire porcelain insulator and ground electrode shield remains in the cylinder head. (Figure 3)

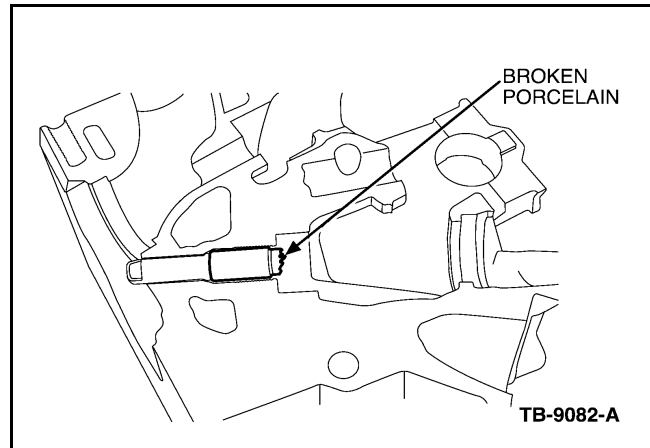
Figure 4 - Article 08-7-6

- c. Mode 3: The upper section of porcelain broke off with remaining porcelain left inside the ground shield. (Figure 4)

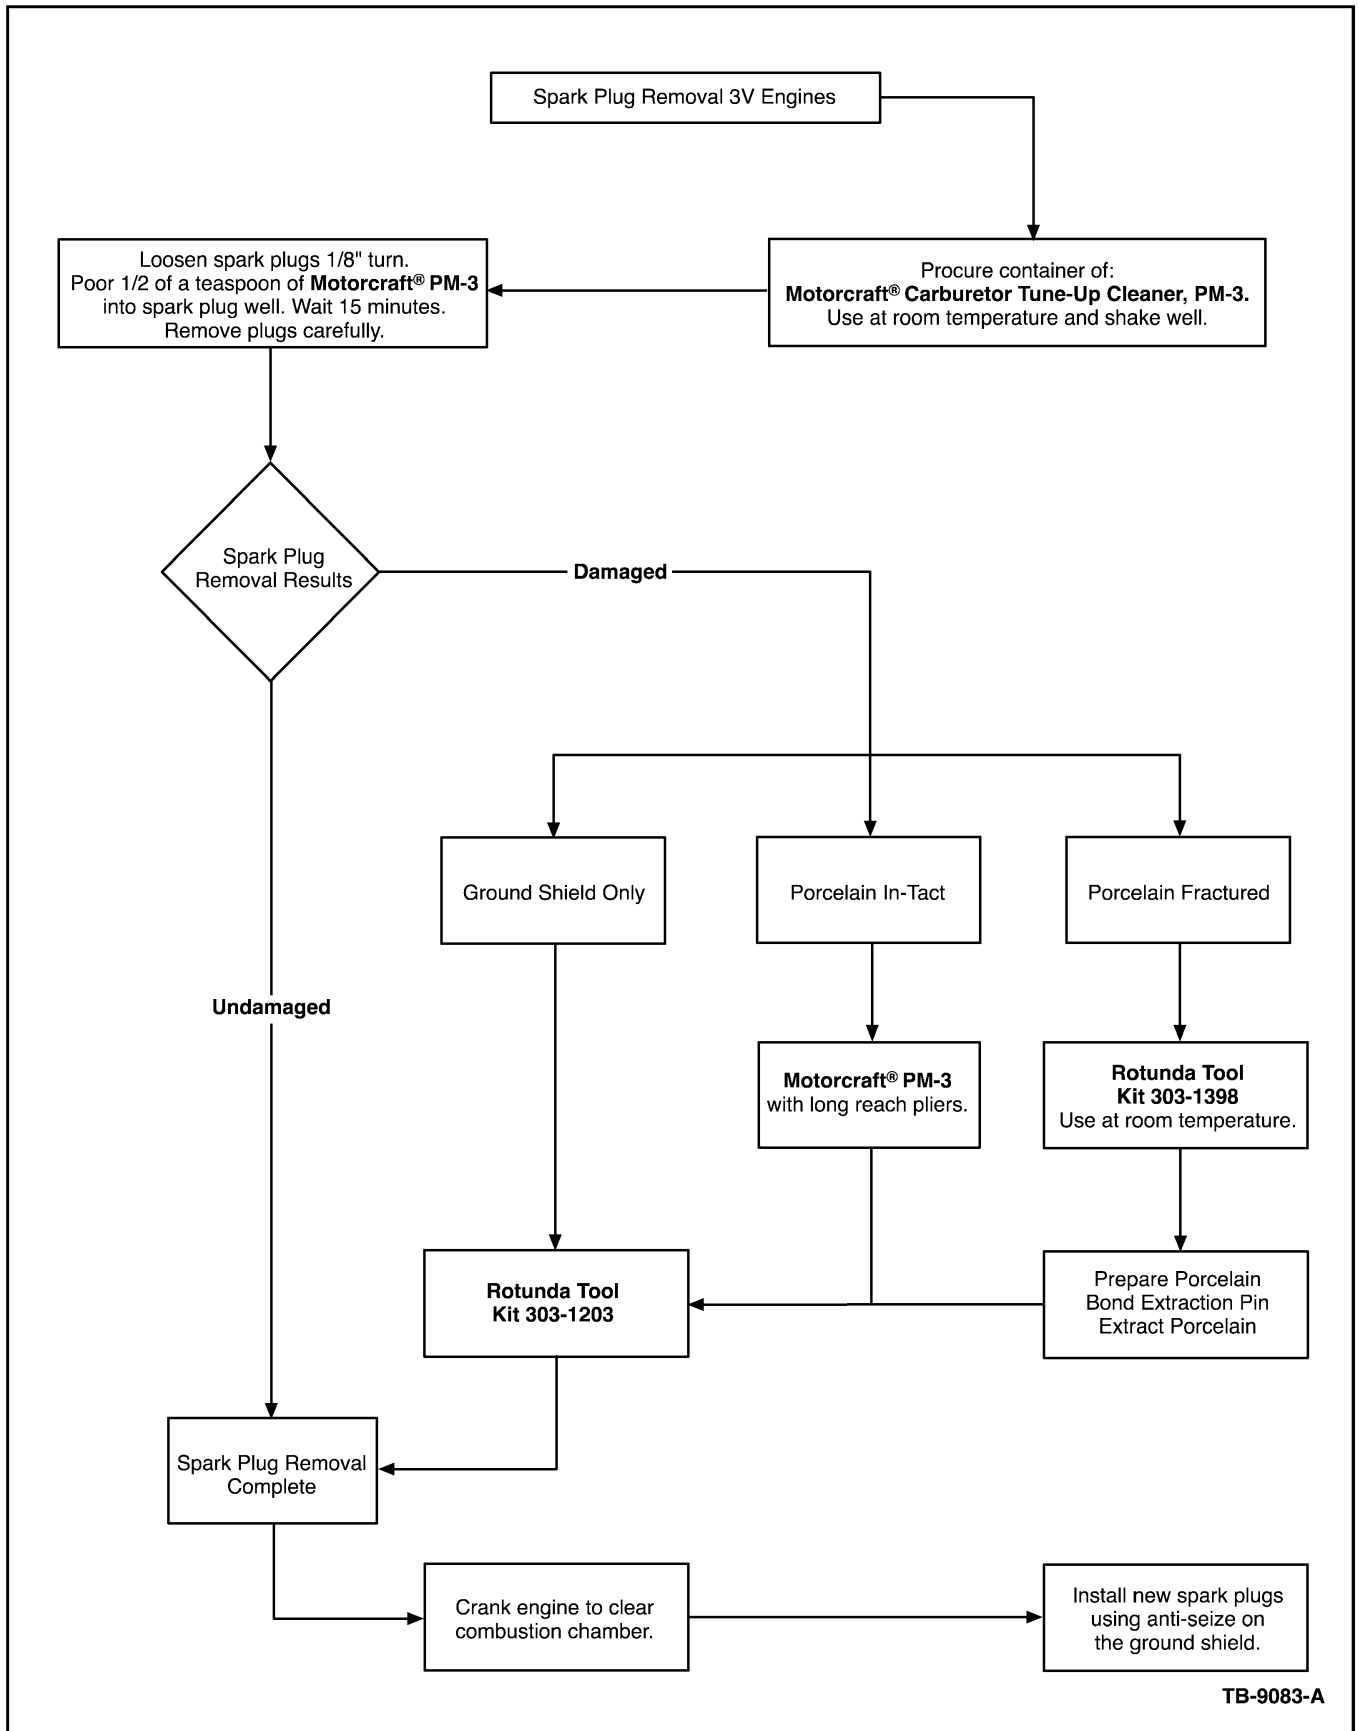
Figure 5 - Article 08-7-6

Flowchart of procedure. (Figure 5)

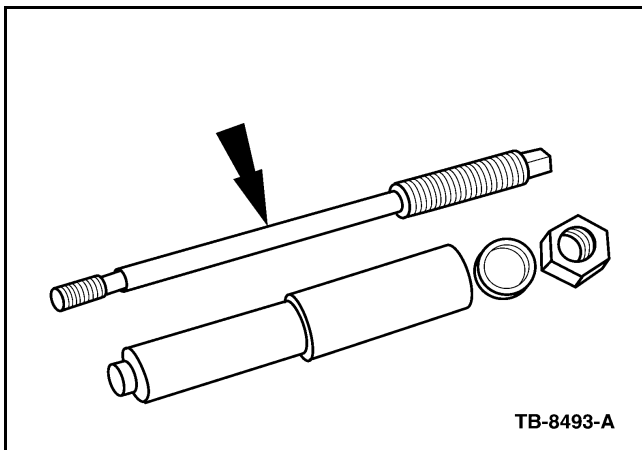
Figure 6 - Article 08-7-6

Use Rotunda special service tool 303-1203 to remove an empty ground electrode shield from the cylinder head. (Figure 6)

THIS TOOL IS ONLY DESIGNED TO WORK WITH AN EMPTY GROUND ELECTRODE SHIELD. IF PORCELAIN REMAINS, PROCEED TO MODE 2 OR 3 REMOVAL.

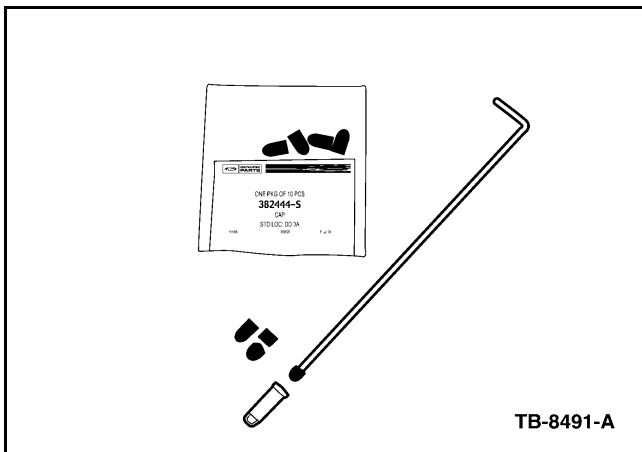
Figure 7 - Article 08-7-6

1. Modify vacuum cap to a 3/8" (10 mm) length for each ground electrode shield that needs to be removed. (Figure 7)

2. Use the installation rod (J) provided with service tool 303-1203 update to install the modified vacuum cap. Push the cap into the ground shield down to the electrode strap. This will plug and protect the combustion chamber from contamination. (Figure 7)
3. Thread-tap the ground electrode shield using a 9.0 x 1.0 mm plug tap (tap profile is about 3-4 reduced diameter threads on the tip end).
 - a. Coat the end of the tap with general purpose grease. (Figure 8)

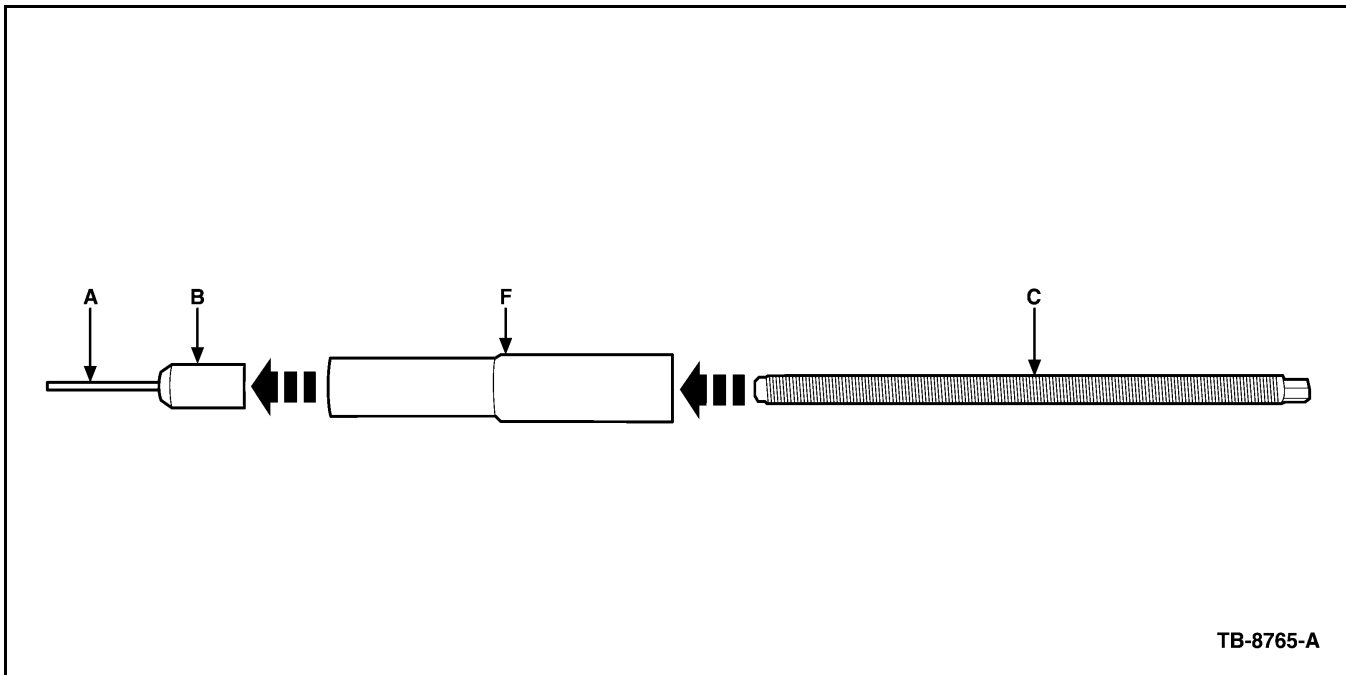
1. Remove any remaining electrode material from broken porcelain with long nose reach pliers.
2. Spray Motorcraft® Metal Brake Parts Cleaner into the porcelain hole for 2-4 seconds using the straw nozzle supplied with the brake cleaner can.
3. Insert a pin (A) into the collet (B). Screw the collet onto the threaded rod (C). Install the assembled collet, pin, and threaded rod into the steel tool pilot (F). (Figures 11 and 12)

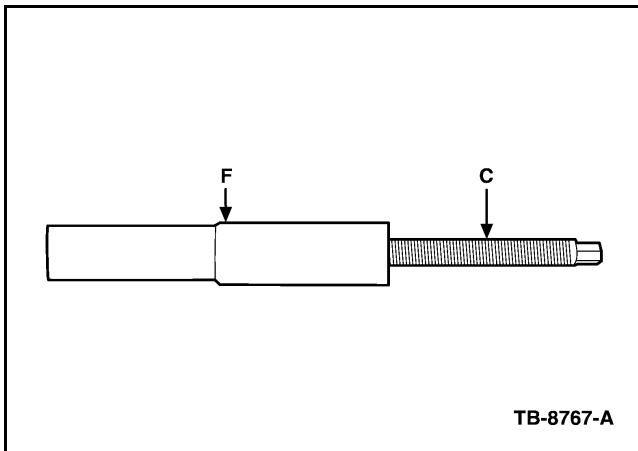
4. Retract the collet and pin into the steel tool pilot, protecting the pin. (Figures 13 and 14)

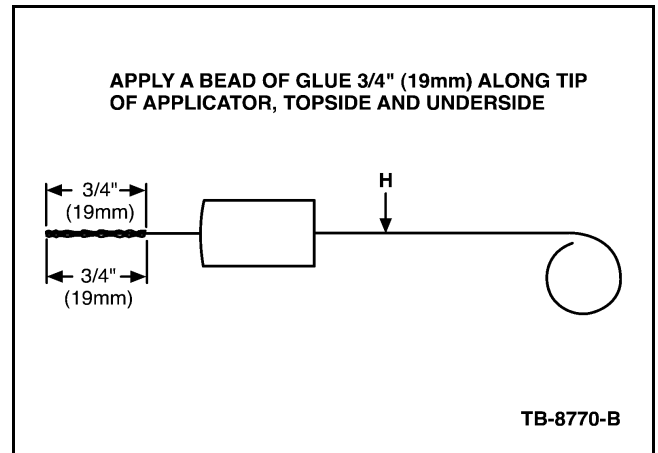
Figure 17 - Article 08-7-6

- Apply two 3/4" (19 mm) long stripes of Loctite® 638™ to opposite sides of a clean and dry applicator (H). Excessive amounts of Loctite® 638™ are being used if it drips off the applicator. (Figure 17)

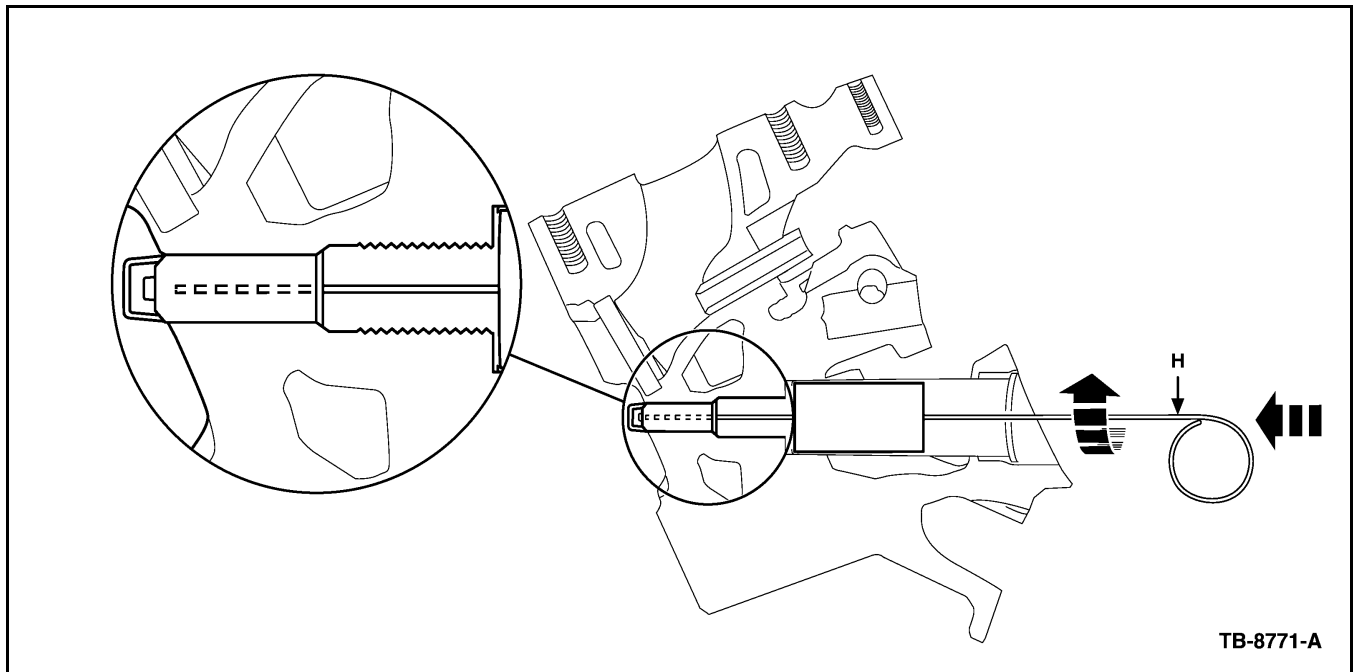
Figure 18 - Article 08-7-6

- Insert applicator into the porcelain and move applicator up and down 1/2" (13 mm) while turning to spread the Loctite® 638™ on the inside of the porcelain. (Figure 18).
